**IDBPI**  
**INSPECT DETECT BUILDING &  
PROPERTY INSPECTIONS**

Inspection Date: 23 Jan 2025

Property Address: Carnegie

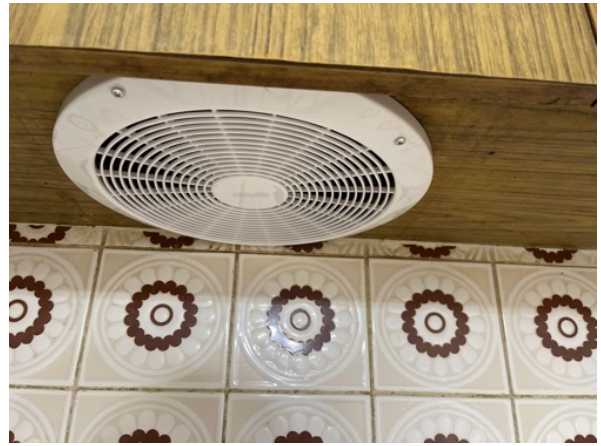
### Serious Safety Hazard 1.02

**Location:** Kitchen/meals  
**Finding:** Safety/fire hazard

Inadequate/non-compliant clearance noted between gas burners and overhead cupboards and exhaust fan.

A non-combustible material must be applied to a 150mm height above top of burners.

A clearance height of no less than 600mm clearance from top of burners and 750mm to exhaust fans

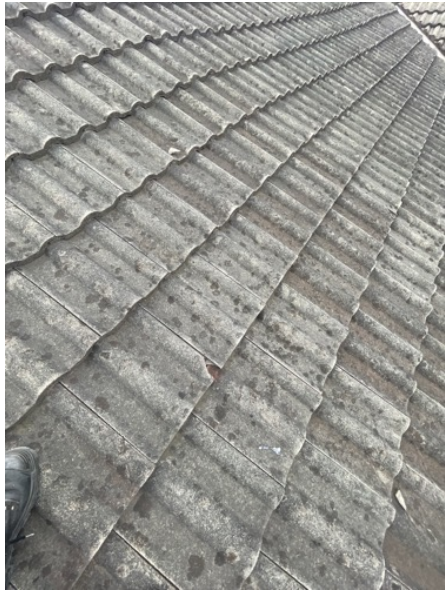
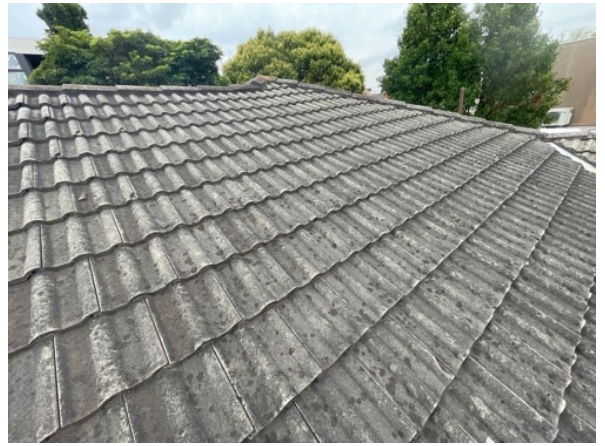
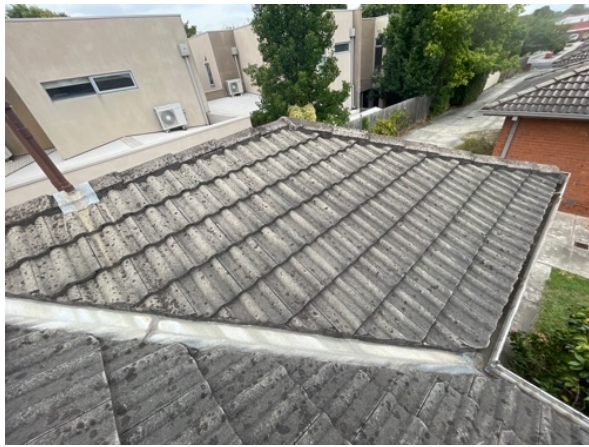
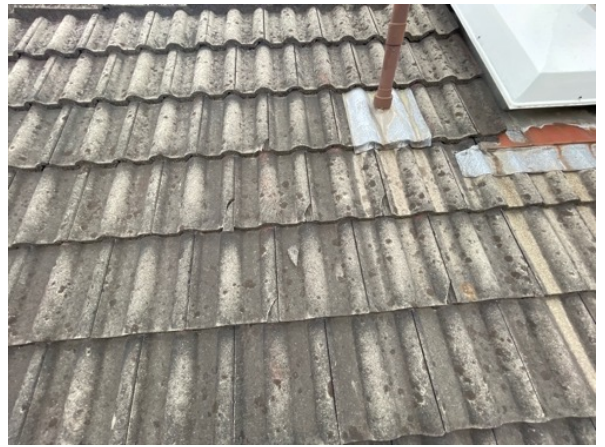
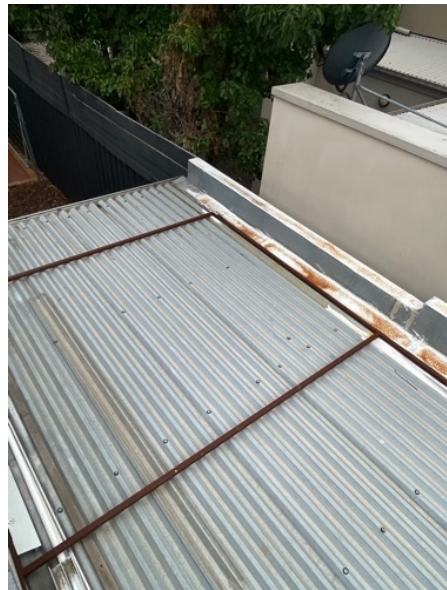
## Major Defect 2.02

**Finding:** Cracked Tiles/Roofing Repairs

Some cracking/dislodgement of cement pointing noted in parts.  
Cracked tiles noted in general to all sides of roof.

Gaps noted between damaged tiles in parts, potential areas of moisture ingress into structure and damage to surrounding building elements.

Tiles appeared starved of sealants.  
Replacement of damaged tiles and resealing required to prevent tiles becoming porous.

Stored goods and corrosion noted to garage metal roofing.  
Some moisture damage noted to garage timber roof frame in parts ( see garage report)

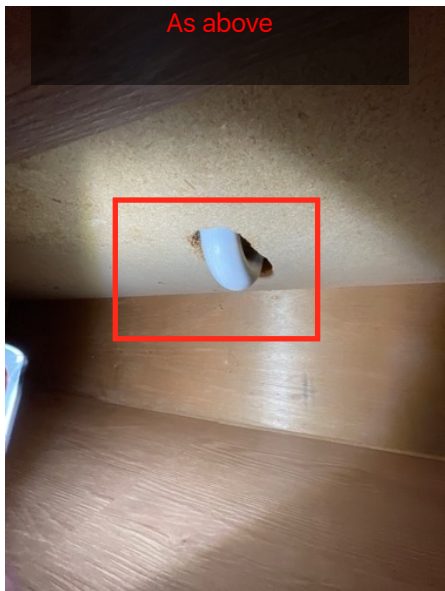
No leak noted

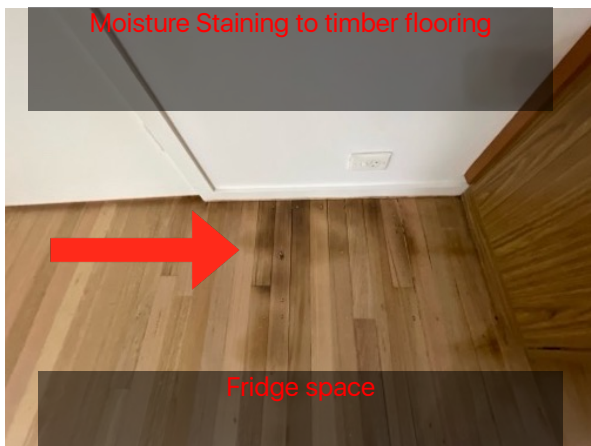
No major moisture damage visible

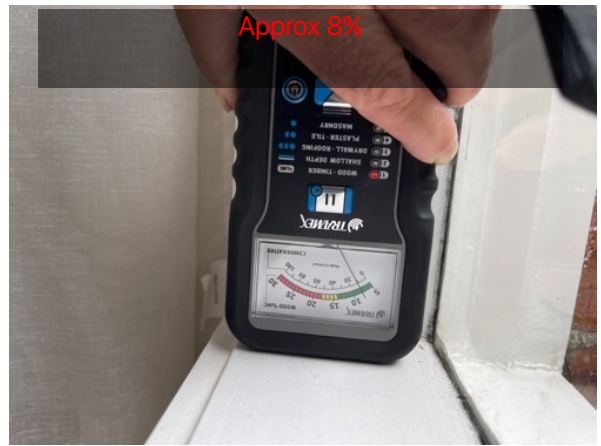
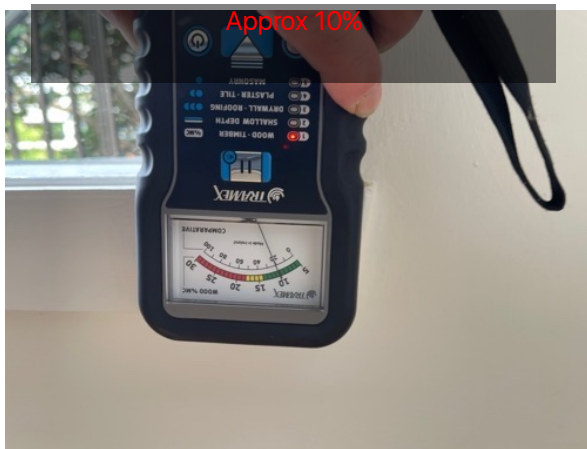
**Location:** Bedroom 1

The bedroom appeared functional and in relatively sound condition at the time of inspection. No notable structural damage noted at the time of inspection. General wear and tear and cuff marks noted in parts.

Entry door adjustments and possible window winder repair/replacement required to function as intended.

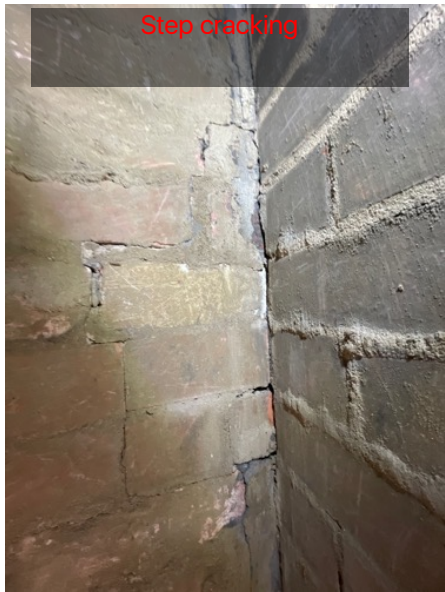
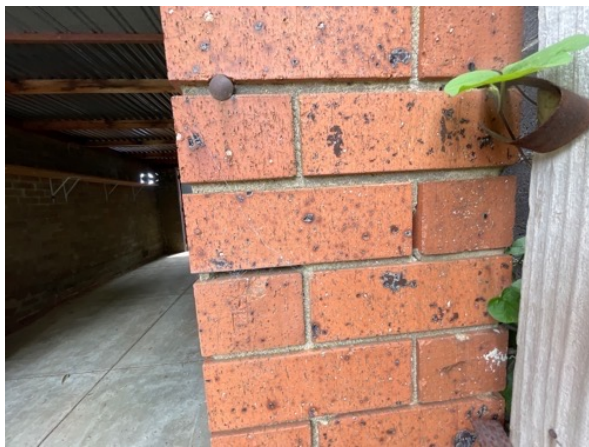
### Minor Defect 3.04

**Finding:** Brickwork - Step cracking

Step cracking was identified to the brickwork in this area at the time of inspection. Where step cracking is extensive or severe, the client is advised to consult a structural engineer. Minor step cracking can be used as a warning sign to address factors causing stress to the wall, which can include the effect of surrounding trees, water leaks, soil erosion, or even the presence of reactive soils in the surrounding area.

Mortar Displacement noted to brick piers in parts, qualified bricklayer to inspect and repair

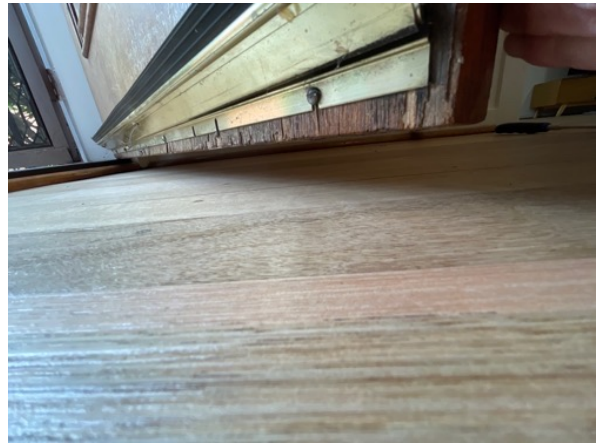
Door leaves are defective if they do not have all sides, top and bottom edges that are sealed to prevent moisture entering

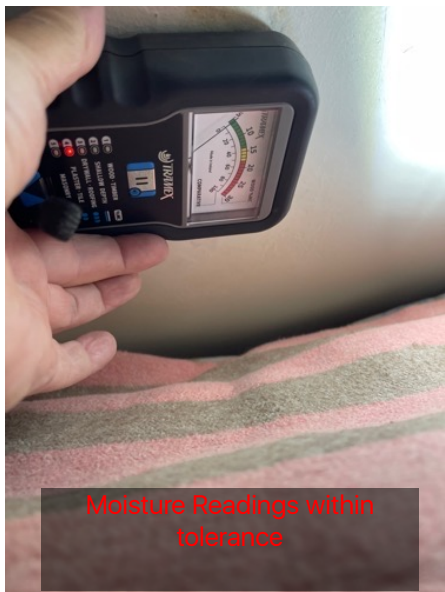
Patching/Stain/mould

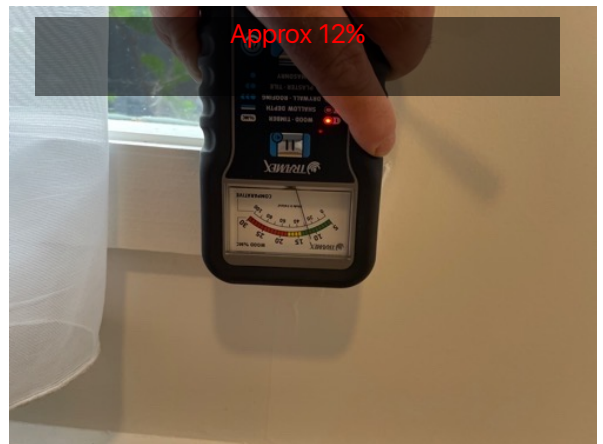
High moisture readings

Approx 12%

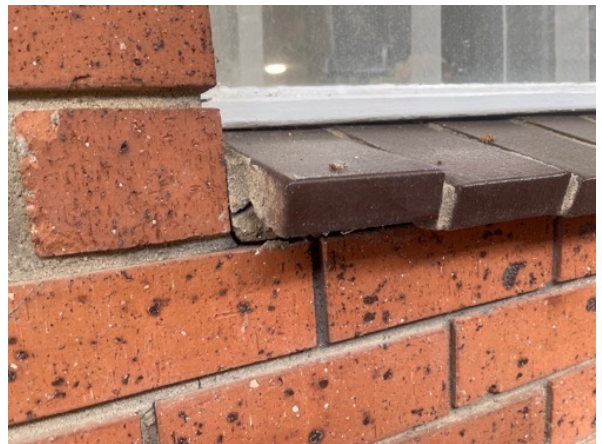
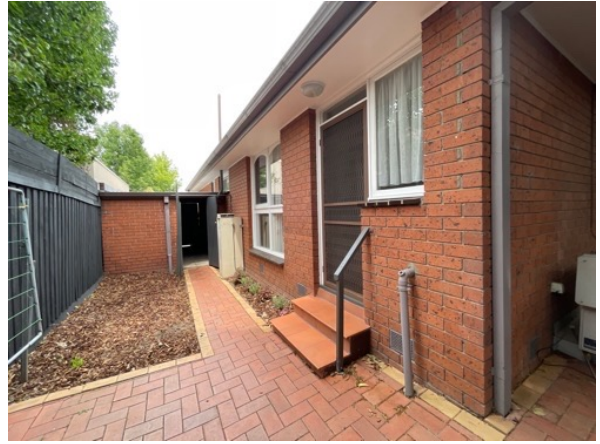
**Location:** External Walls

Loose sill bricks potential areas of moisture ingress into structure and damage to surrounding building elements and conditions conducive for timber pest activities and infestations.

Engage a qualified bricklayer to inspect and advise on refitting costs.

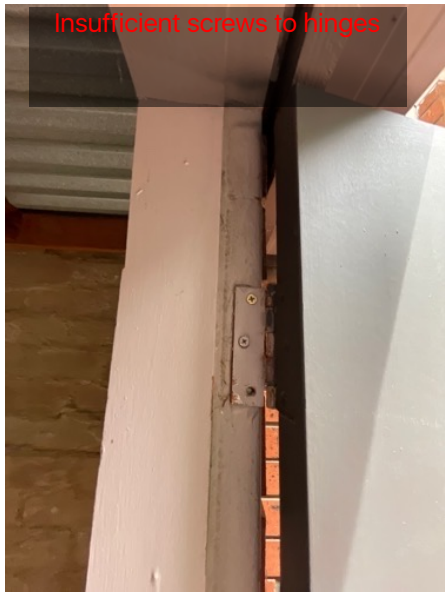
Timber garage exit door damaged in parts. Repairs, replacement recommended. No working door lock noted.

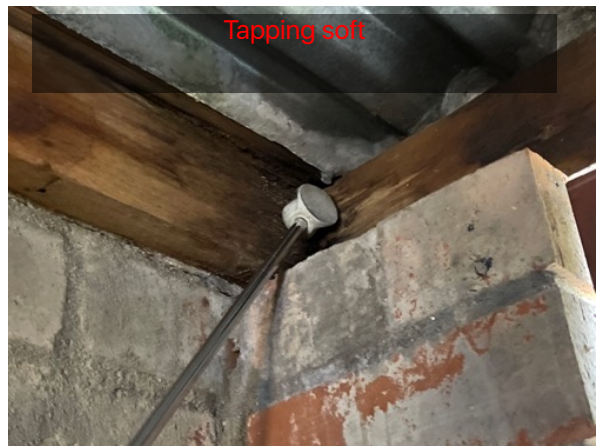
Moisture ingress damage

Tapping soft

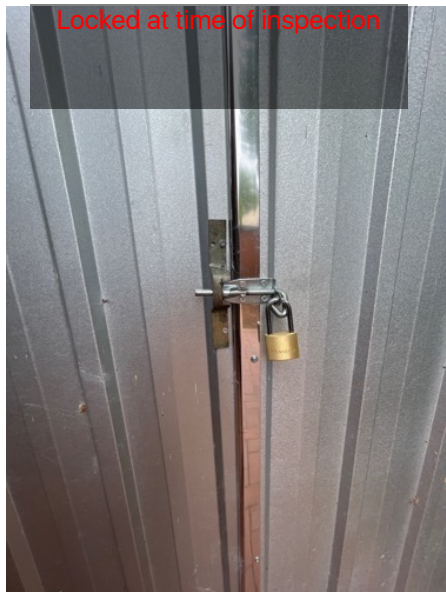
**Location:** The Site

The shed poorly installed and leaning against trees. Trees growing over shed. Shed was locked at time of inspection obstructing full access inspection.
