**IDBPI**  
**INSPECT DETECT BUILDING &  
PROPERTY INSPECTIONS**

Inspection Date: 23 Jan 2025

Property Address: Carnegie

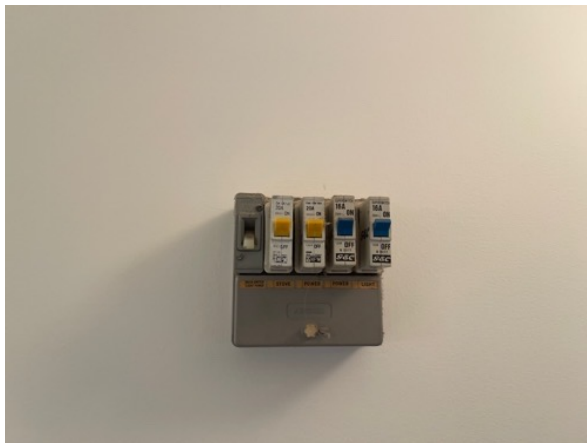
**Location:** Entry Hallway  
**Finding:** Electrical Upgrades

Old fuse box noted to meter box, upgrading to safety switches strongly recommended to prevent possible electrical overload, fire's to property and or electrocution to persons  
 A regulation under the residential tenancies act.  
 Old fuse boxes may not be covered by insurance policy

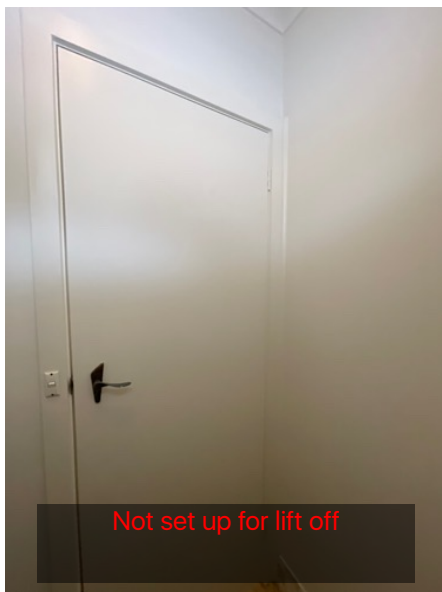
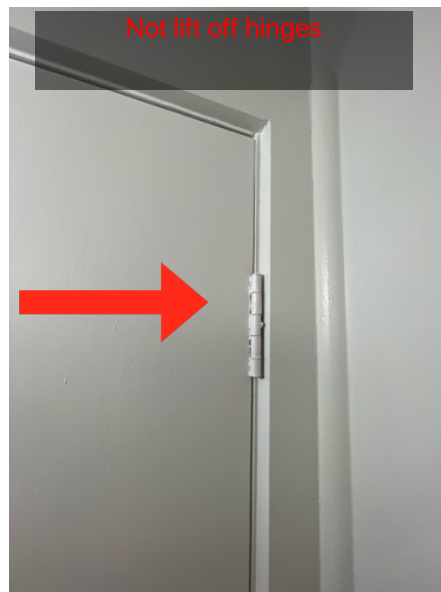
**Location:** Powder/Toilet Room

Where distance between leading edge of door and closest point of toilet pan less than 1200mm noted, lift-off hinges and sufficient gap between door and door frame header required to allow door removal in case of medical emergency

First introduced in 1996 may not have been a regulation at time of property build  
A requirement under the residential tenancy act for investment properties

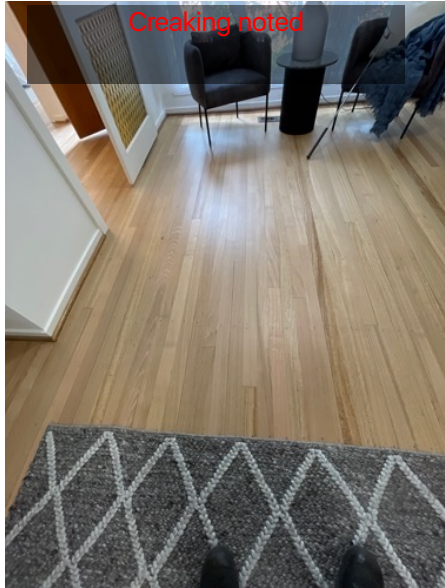
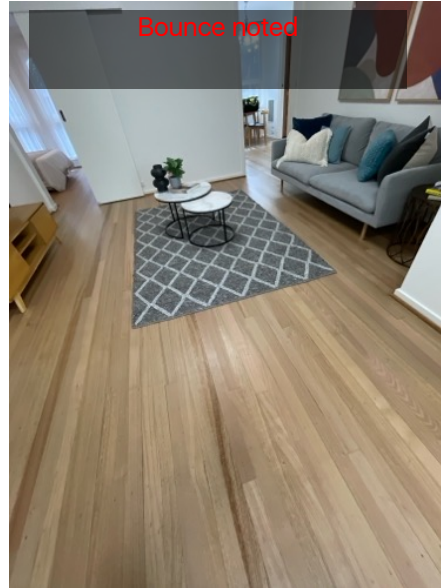
## Major Defect 2.01

An invasive inspection by disconnecting ductwork and other low hanging building components to subfloor may be required to determine cause of creaking to flooring.

Engagement of a licensed/qualified re-stumper recommended

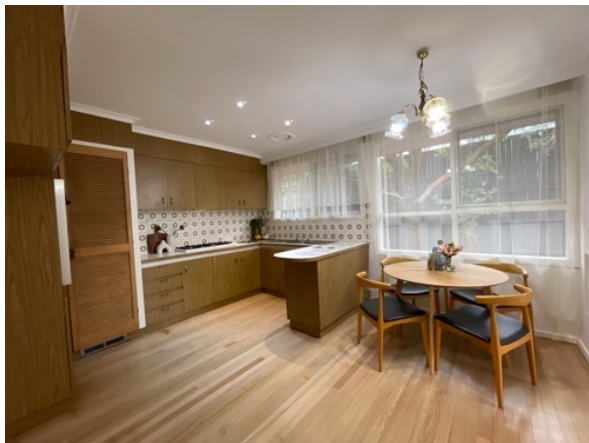
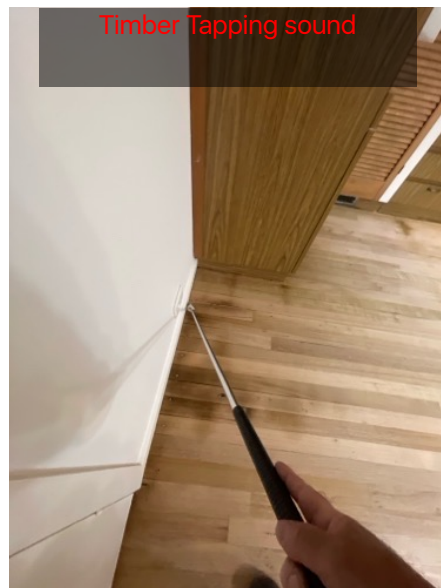
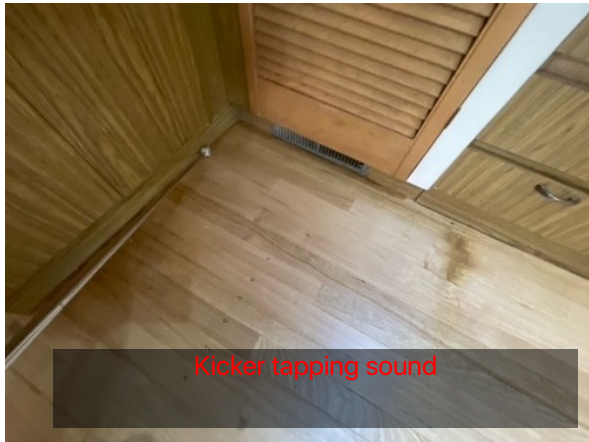
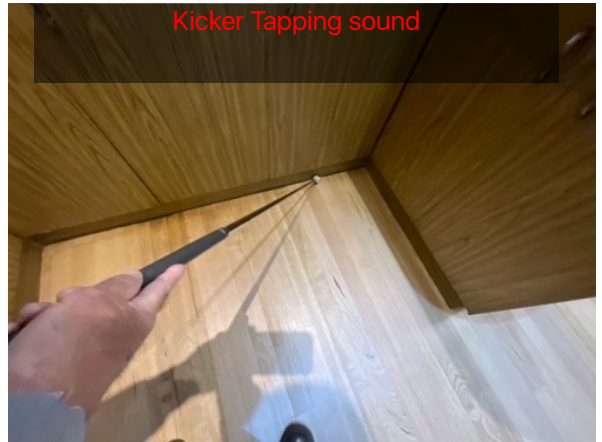
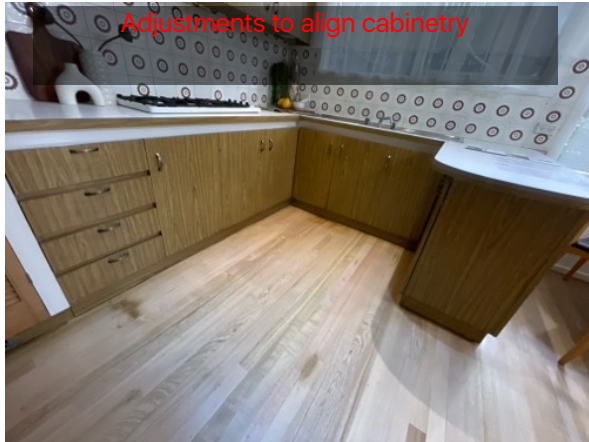
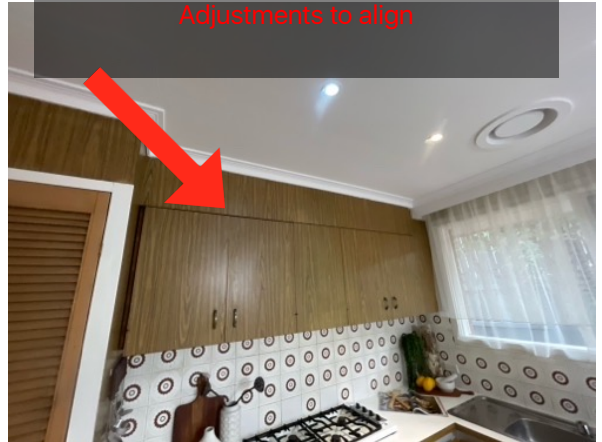
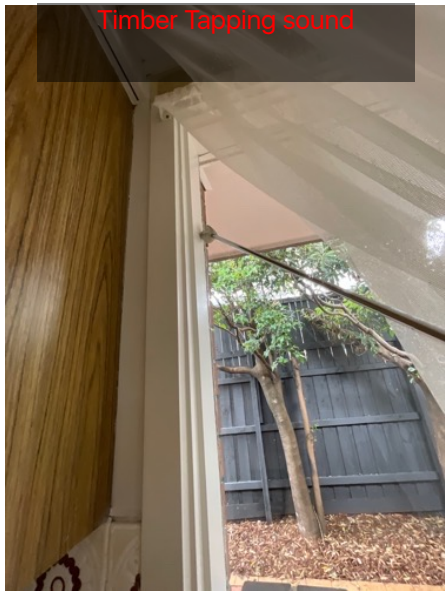
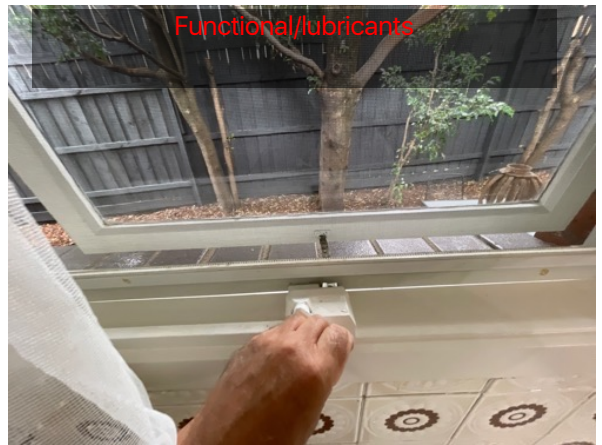
### Minor Defect 3.01

Moisture readings taken at the time of inspection, appeared within tolerance at the time of inspection.

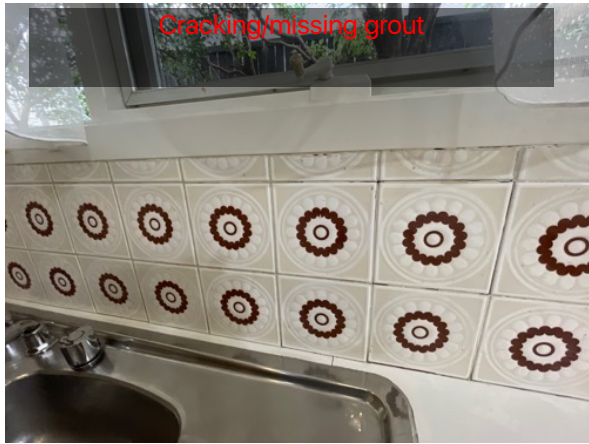
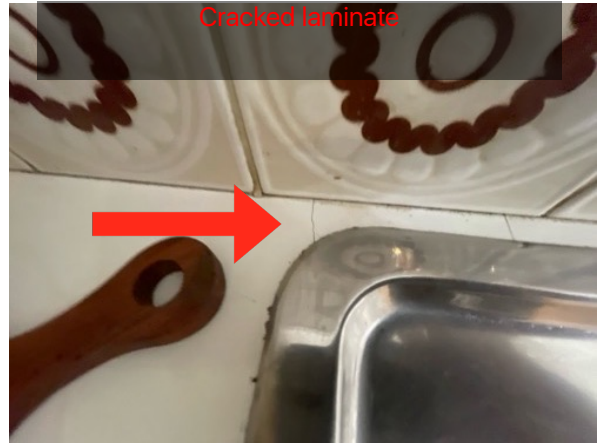
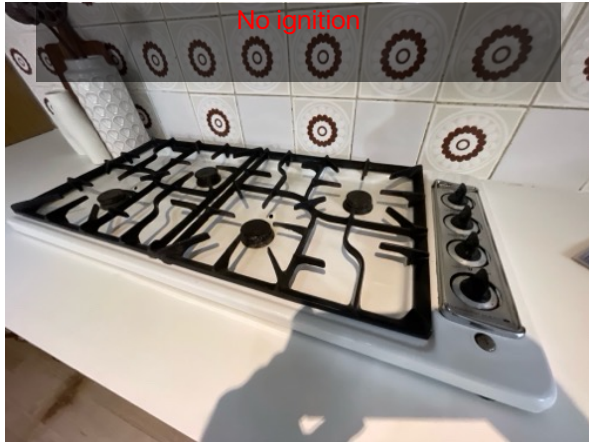
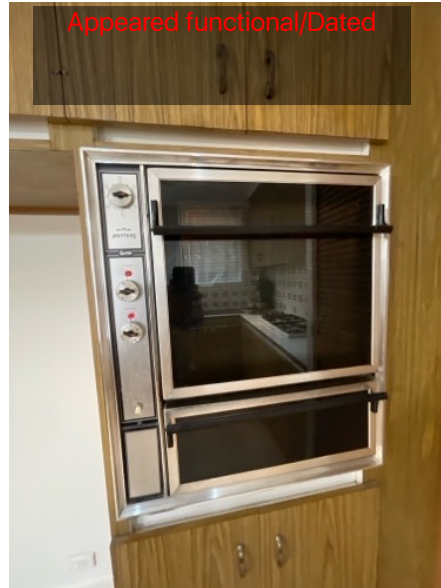
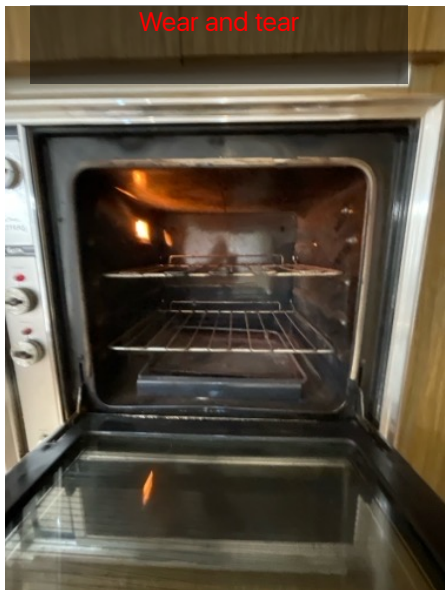
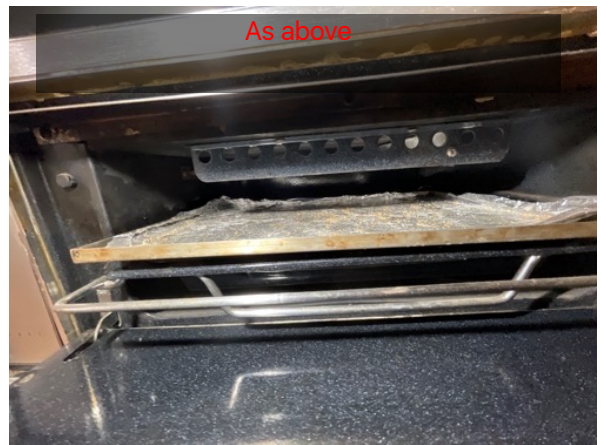
Appliances appeared well worn.

Cracked/dislodged grout noted to tile splash backs.

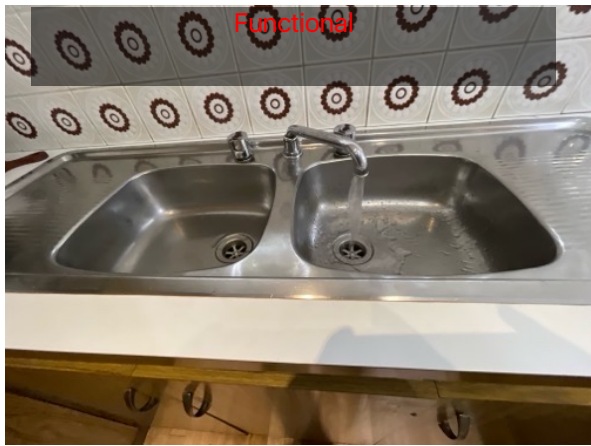
Functional

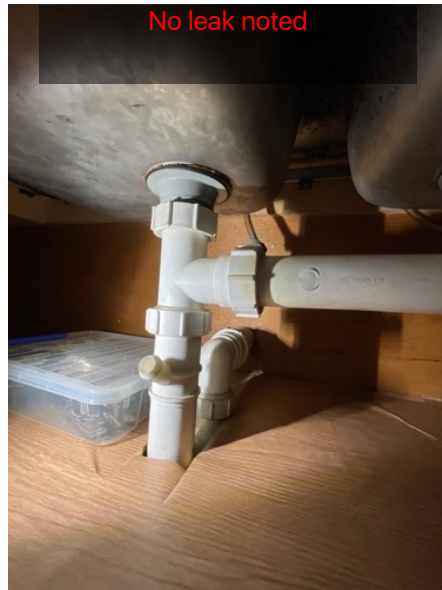
No leak noted

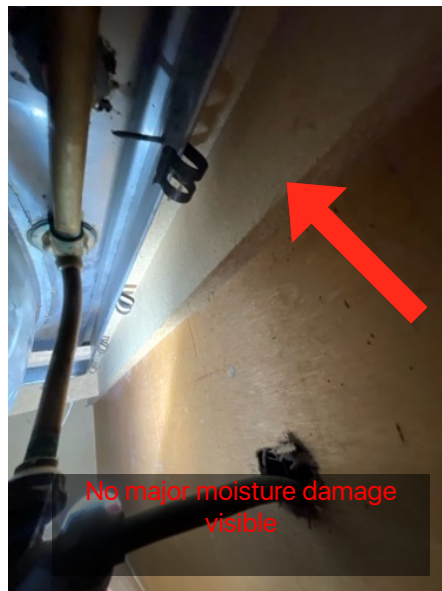
No major moisture damage visible

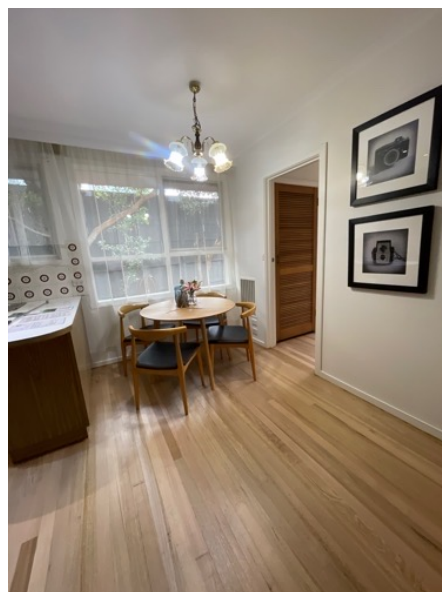
Fridge space

Moisture Staining to timber flooring

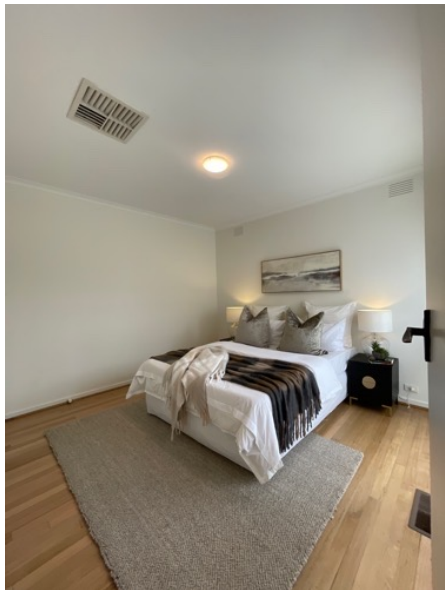
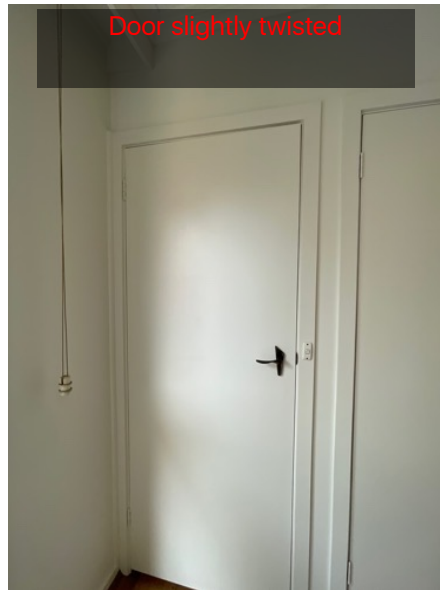
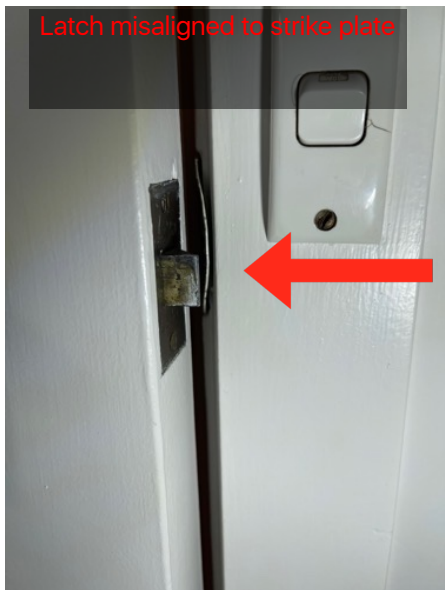
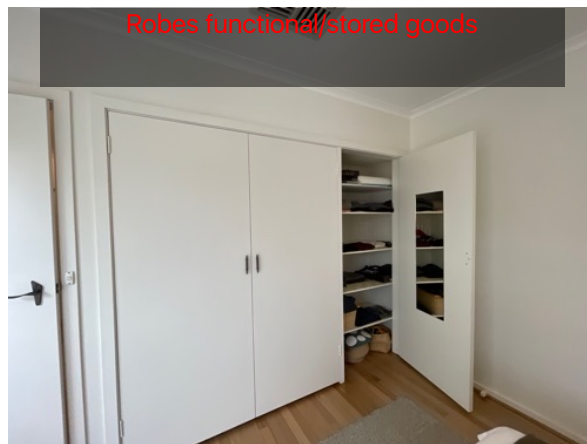
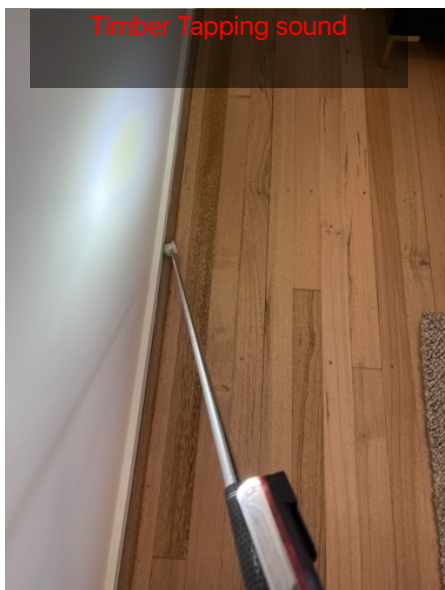
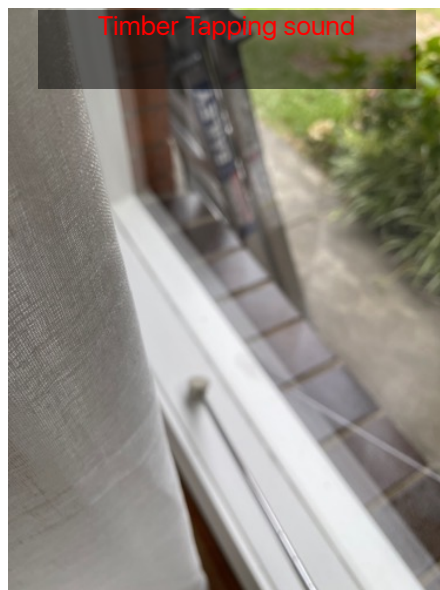
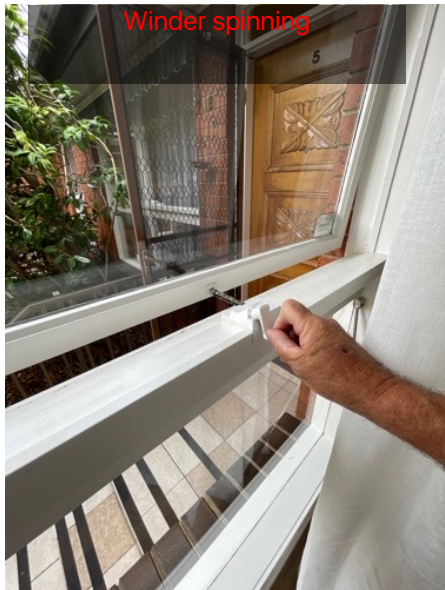
**Location:** Bedroom 1

The bedroom appeared functional and in relatively sound condition at the time of inspection. No notable structural damage noted at the time of inspection. General wear and tear and cuff marks noted in parts.

Entry door adjustments and possible window winder repair/replacement required to function as intended.

Obstructed access inspection noted due to high volume of stored goods, furniture and/or personal items.

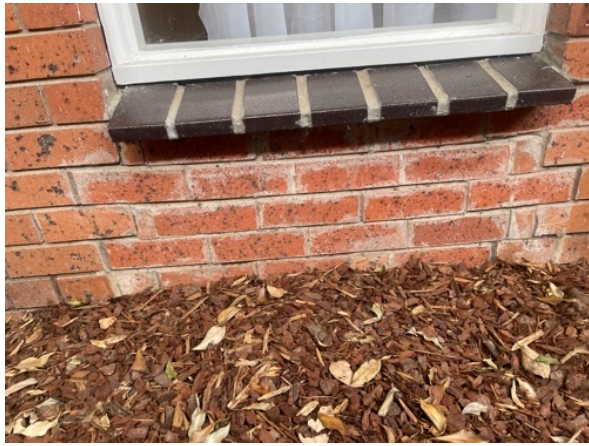
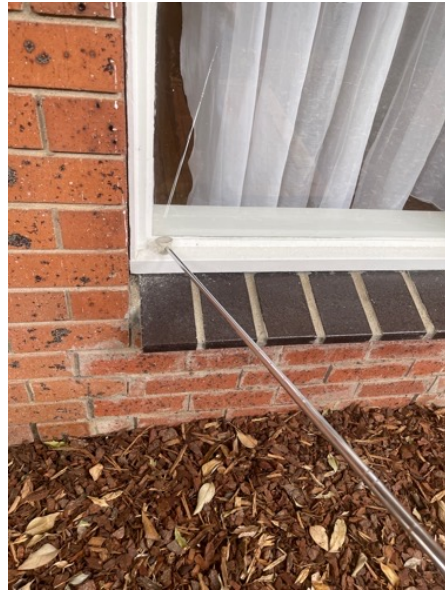
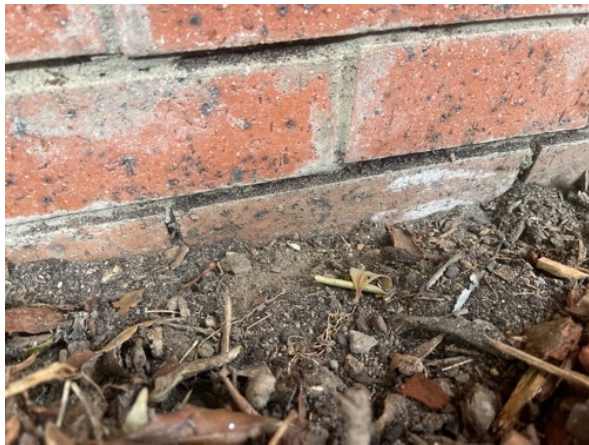
**Location:** External Walls

**Finding:** Brickwork Repairs

Repairs noted to face brickwork under 3rd bedroom window opening.

Repairs to window sill and high moisture readings noted to window frames internally.

It may be probable that brickwork infill may be concealing damage.

Seek clarification from vendors in writing regarding reason for brickwork repairs and knowledge of termite activities, infestations and/or historical damage during vendors ownership of property

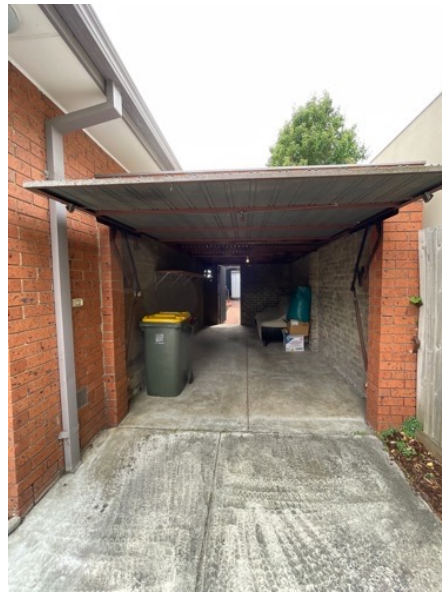
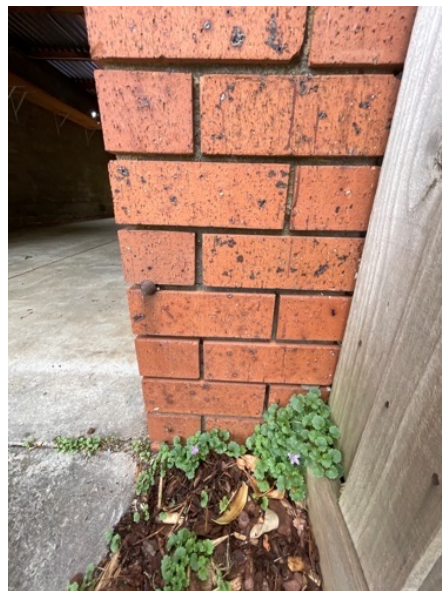
**Location:** Garage

**Finding:** Brickwork - Step cracking

Step cracking was identified to the brickwork in this area at the time of inspection. Where step cracking is extensive or severe, the client is advised to consult a structural engineer. Minor step cracking can be used as a warning sign to address factors causing stress to the wall, which can include the effect of surrounding trees, water leaks, soil erosion, or even the presence of reactive soils in the surrounding area.

Mortar Displacement noted to brick piers in parts, qualified bricklayer to inspect and repair

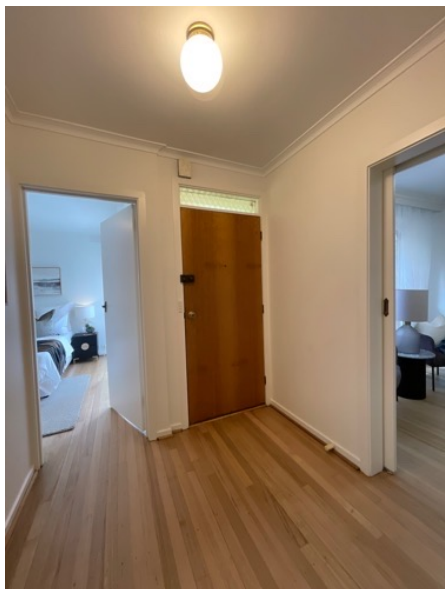
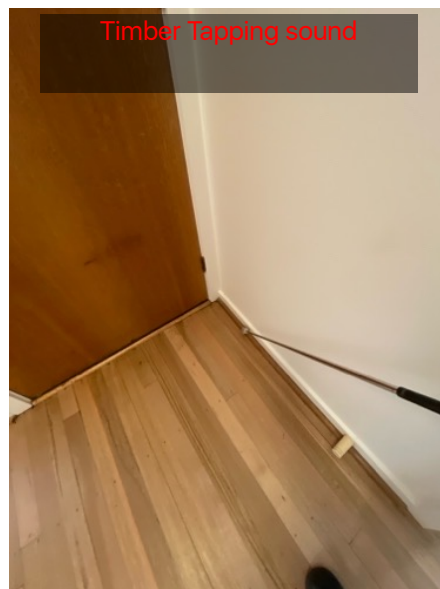
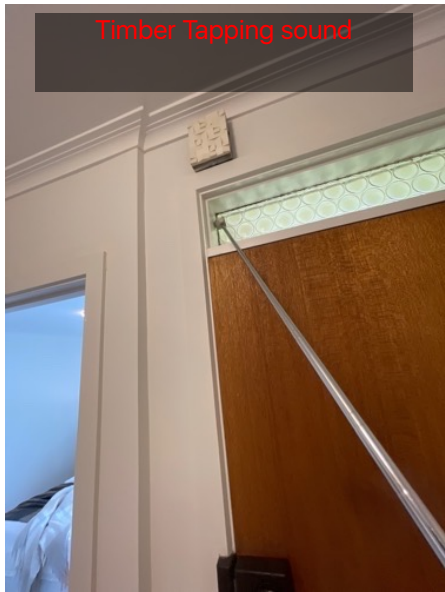
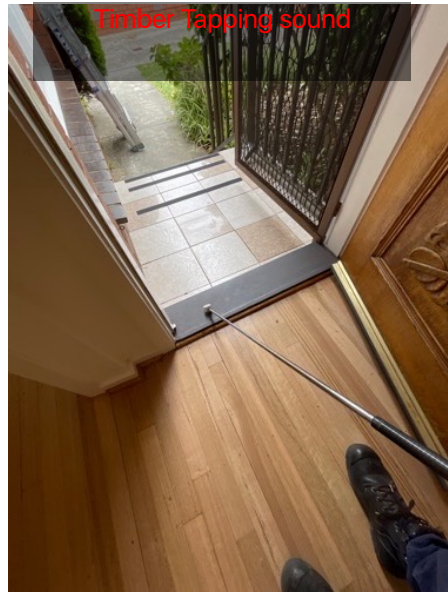
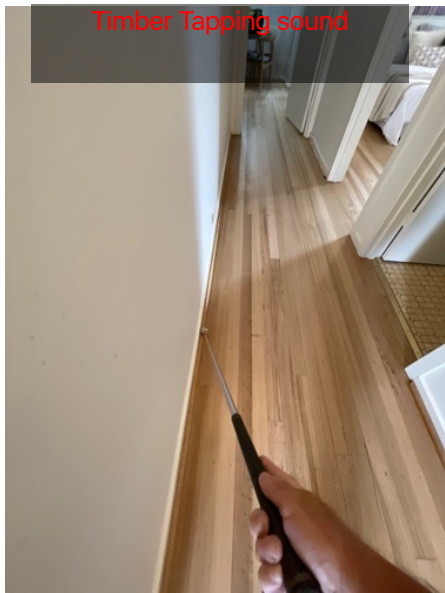
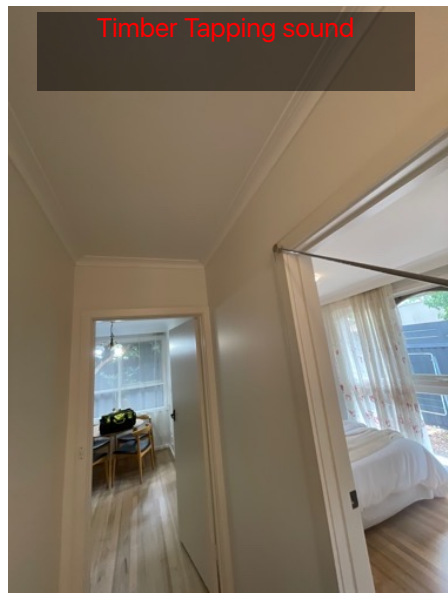
**Finding:** Sound Condition

The entry hallway appeared functional and in relatively sound condition at the time of inspection.

Fresh painting over general wear and tear noted throughout property.

Moisture readings to timber components taken at the time of inspection, averages appeared between 8-12% at the time of inspection.

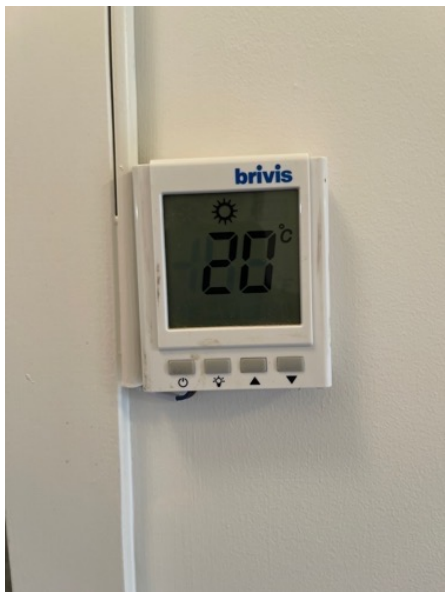
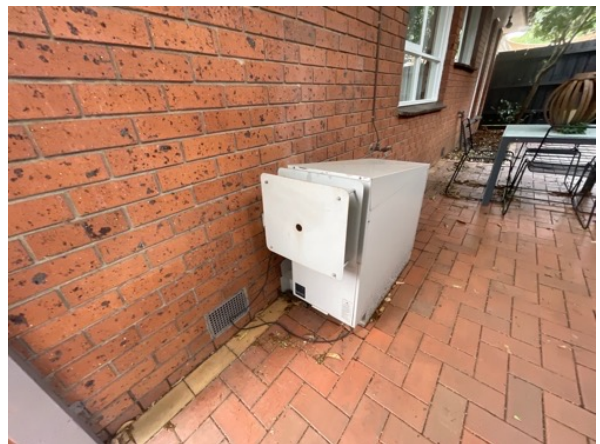
**Location:** Heater  
**Finding:** Functional  
The heater appeared functional at time of inspection

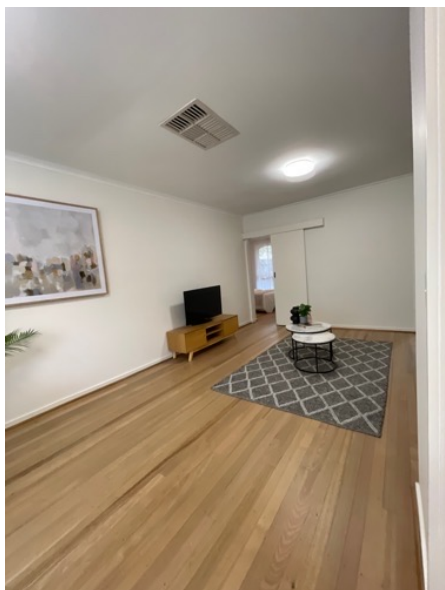
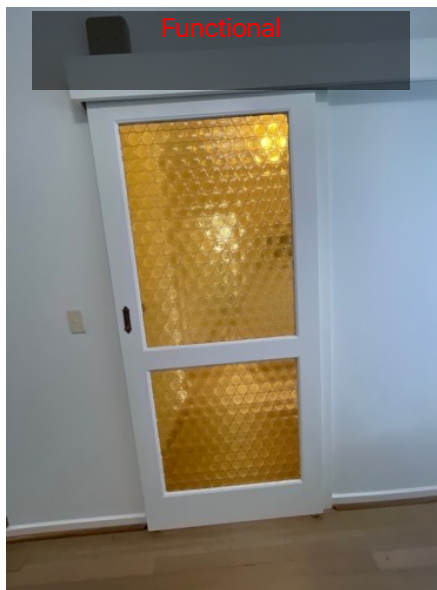
**Location:** Living Room

The living room appeared functional and in relatively sound condition at the time of inspection. No notable structural damage noted at the time of inspection.

Patching/repairs and painting noted throughout, some paint blemishes noted.

Visible jointing lines noted throughout ceiling suggested possible hairline jointing cracking prior to repainting.

Obstructed access inspection noted due to high volume of stored goods, furniture and/or personal items.

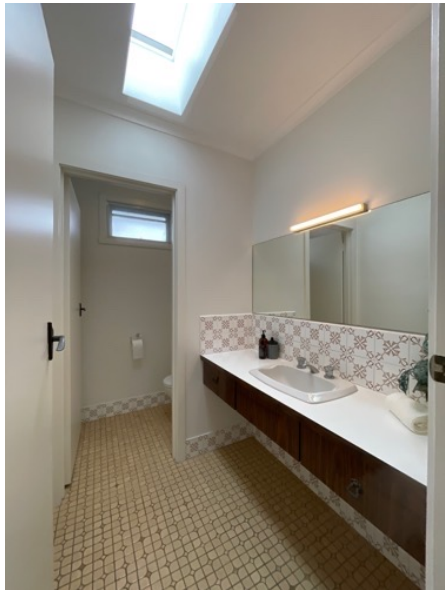
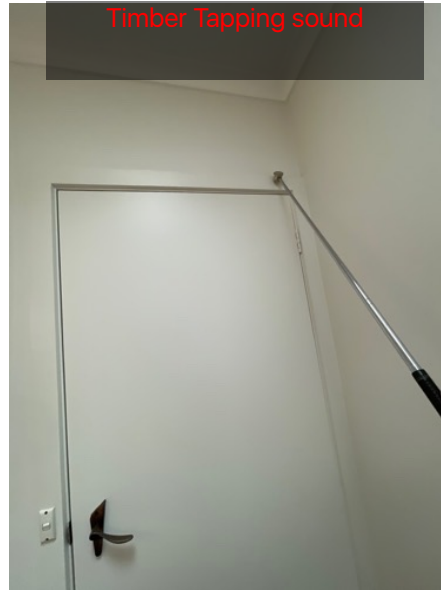
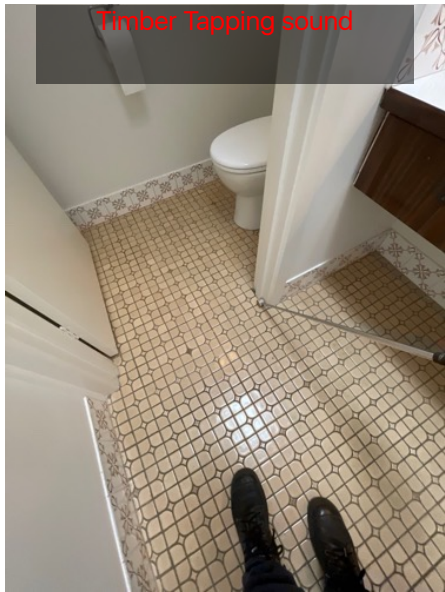
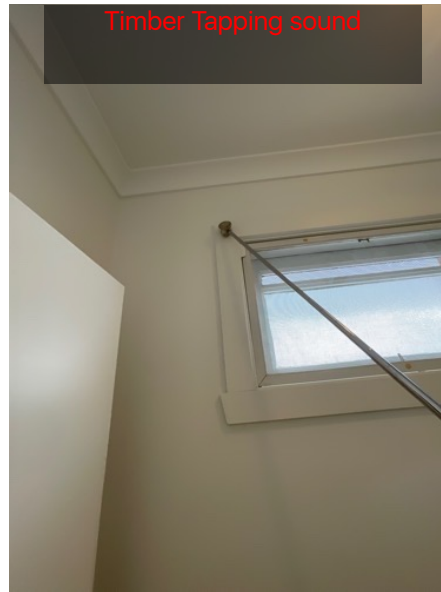
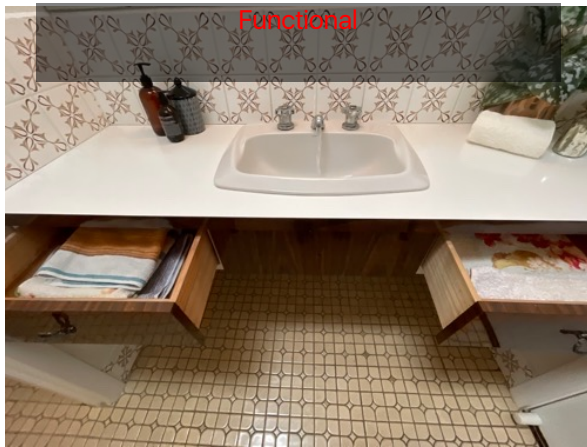
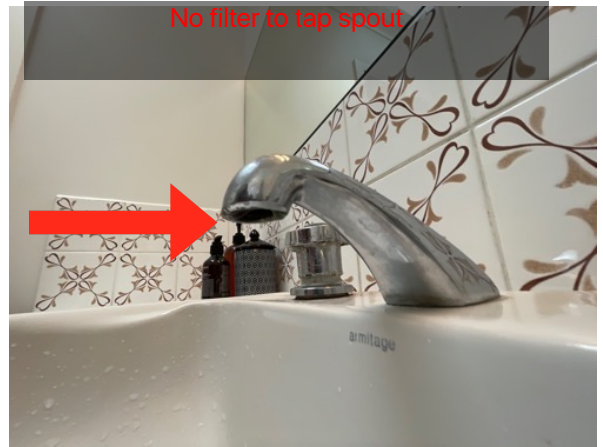
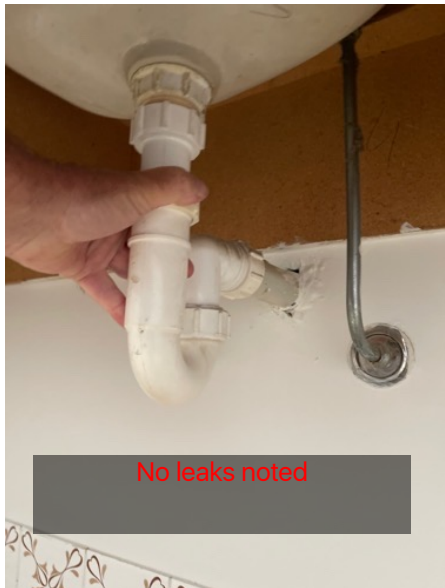
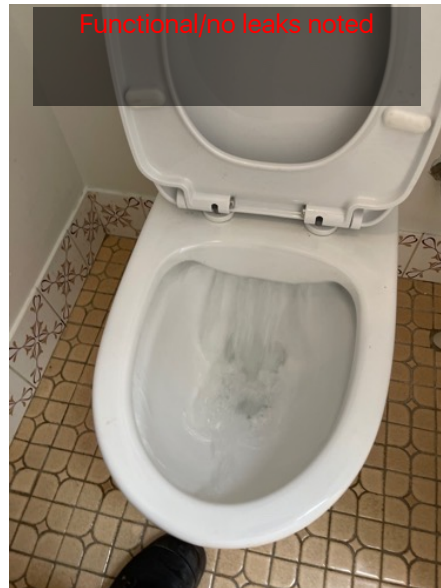
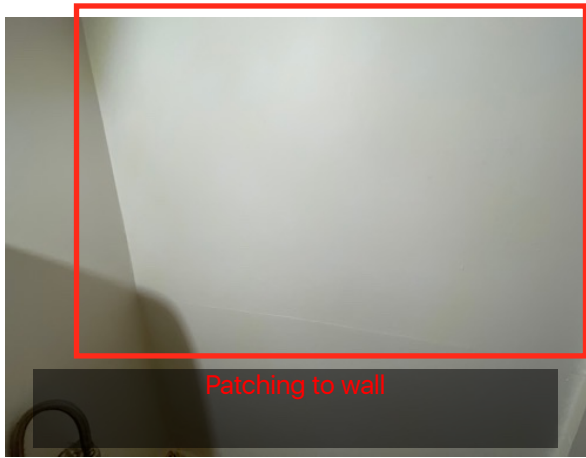
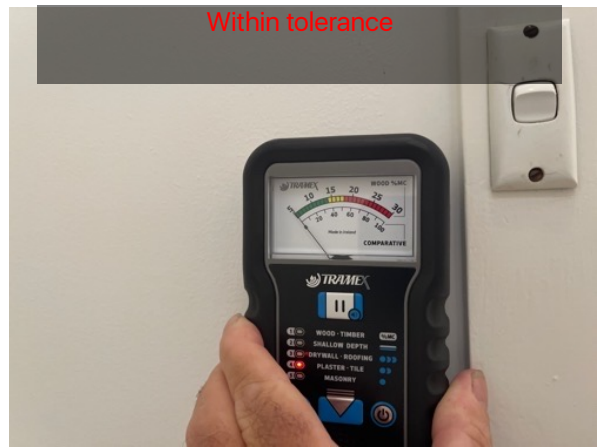
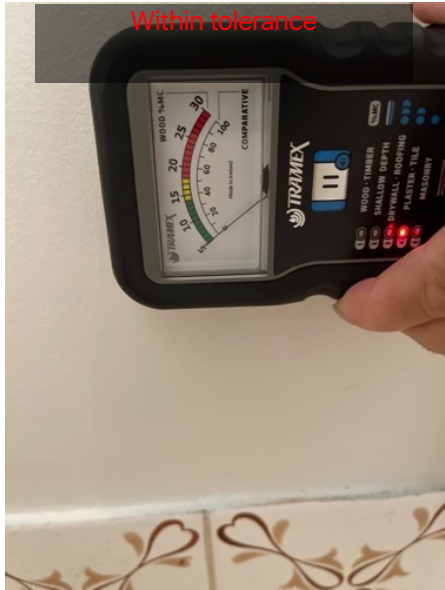
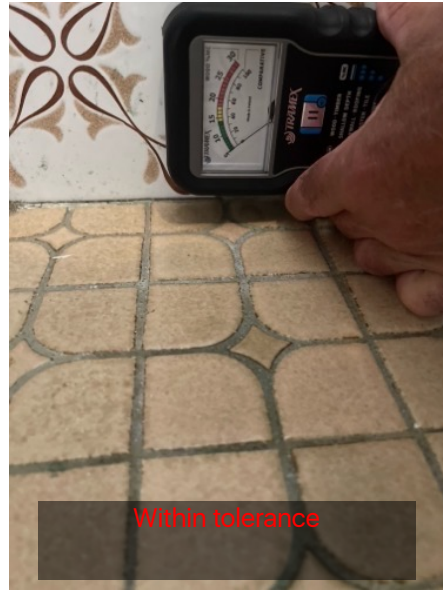
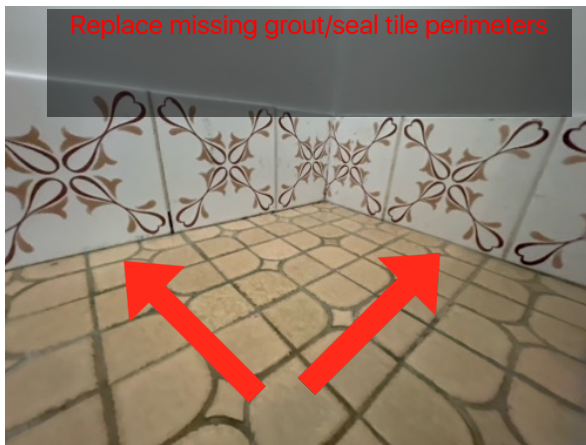
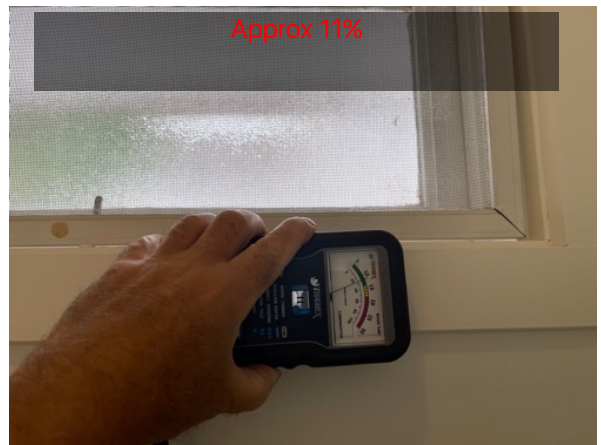
### For your information 4.04

**Finding:** Functional Condition

The powder room and toilet appeared functional and in relatively sound condition at the time of inspection.

No notable structural damage noted.

No notable plumbing leaks noted at the time of inspection

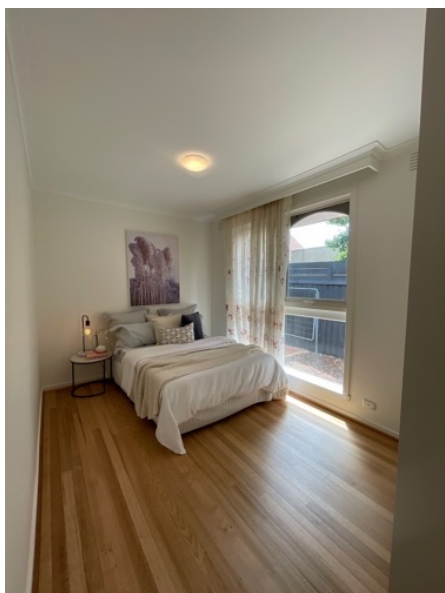
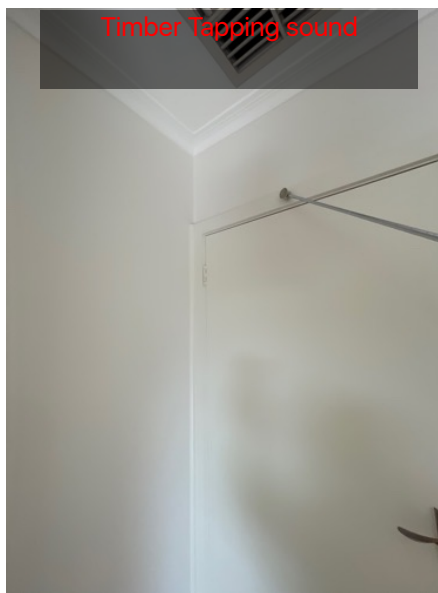
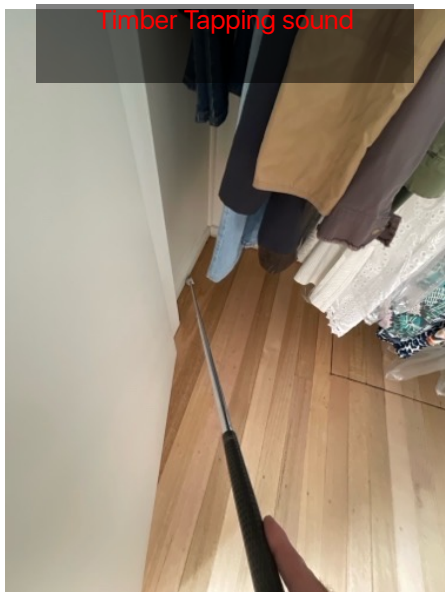
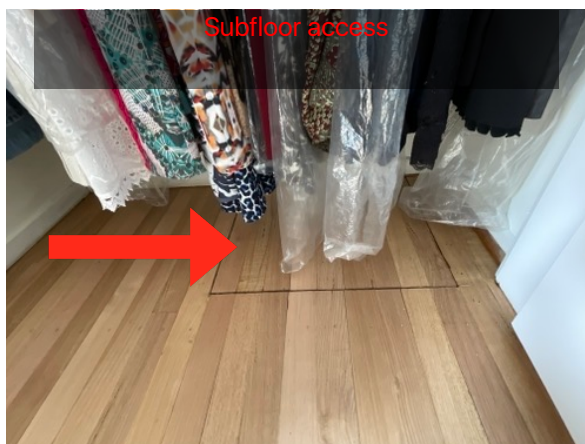
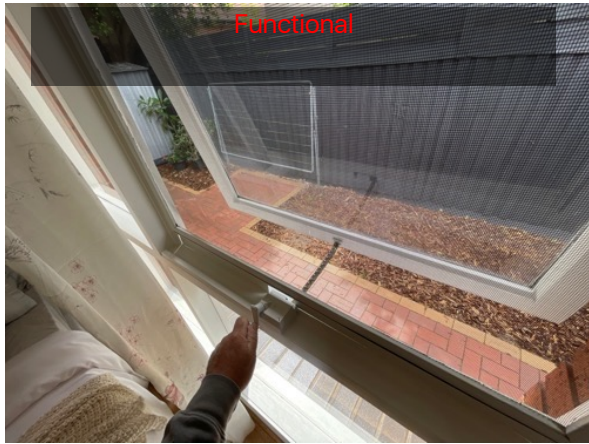
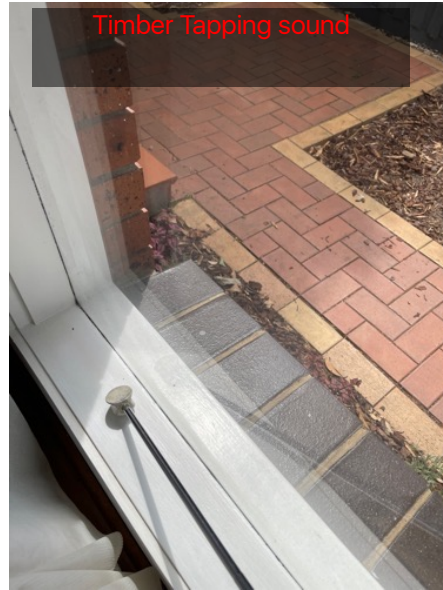
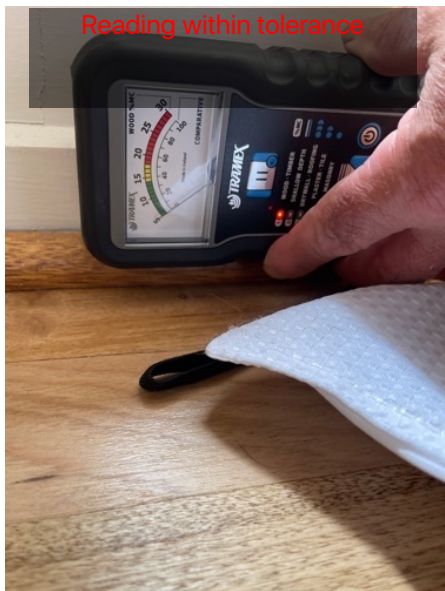
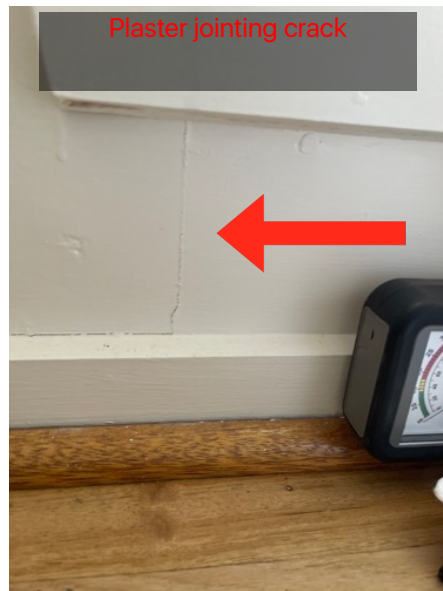
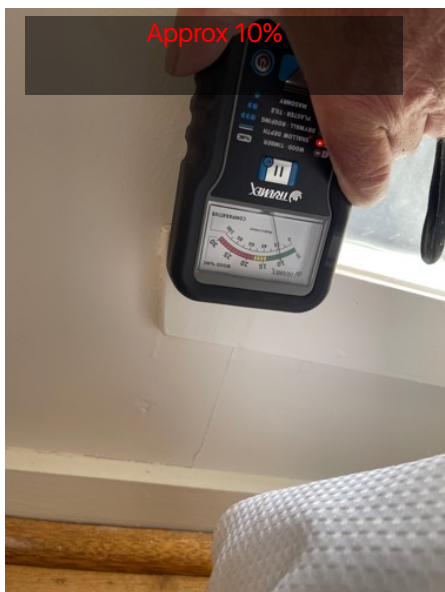
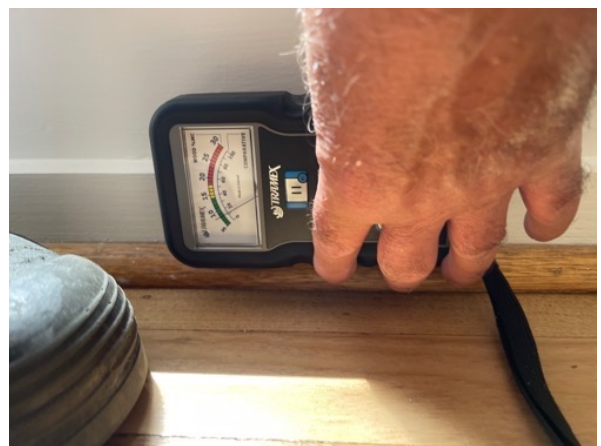
## For your information 4.05

**Finding:** Functional Condition

The bedroom appeared functional and in relatively sound condition at the time of inspection. No notable structural damage noted at the time of inspection. General wear and tear and cuff marks noted in parts Where accessible and visual for inspection and tapping, accessible timber's tapped appeared in relatively sound condition.

Obstructed access inspection noted due to high volume of stored goods, furniture and/or personal items.

Moisture readings taken at the time of inspection, appeared within tolerance at the time of inspection.

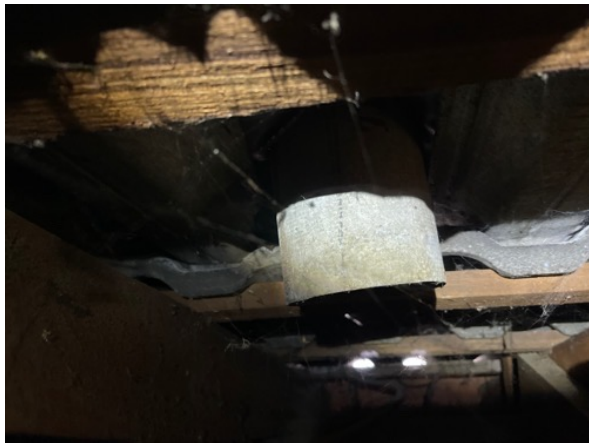
**Location:** Roof Space

Old heater flue noted to roof space.

Potential area of moisture ingress into structure

Removal and disposal by a licensed asbestos contractor recommended

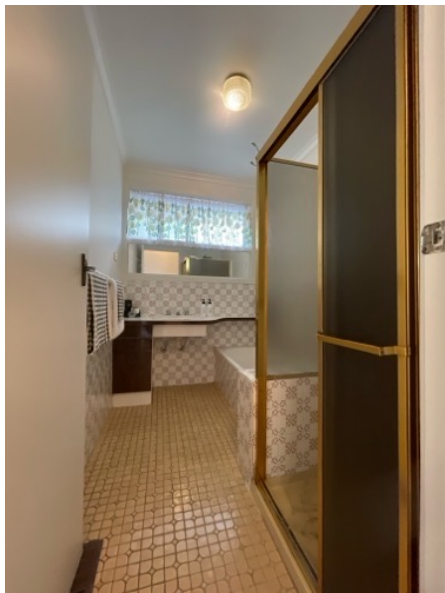
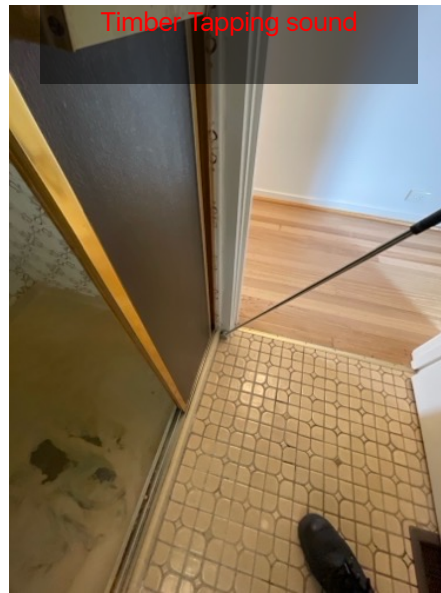
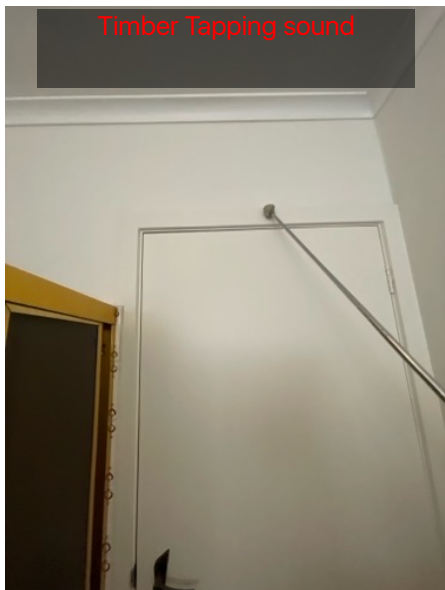
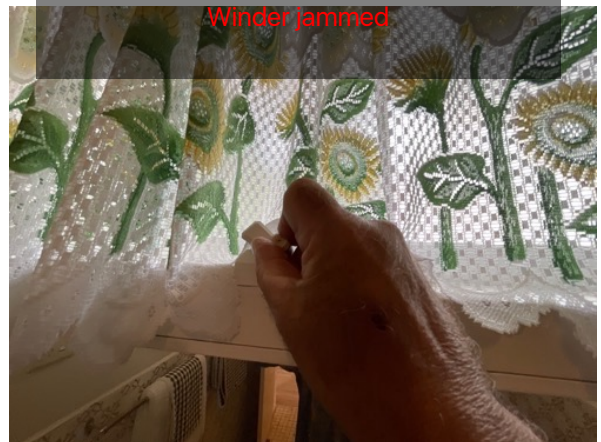
Tap penetrations to shower recess not silicone sealed as required to prevent potential moisture ingress into structure and damage to surrounding building elements.

An invasive inspection may be required to determine cause of damage and high moisture readings and extent of damage and/or timber pest activities and infestations
