**IDBPI**  
**INSPECT DETECT BUILDING &  
PROPERTY INSPECTIONS**

Inspection Date: 23 Jan 2025

Property Address: Carnegie

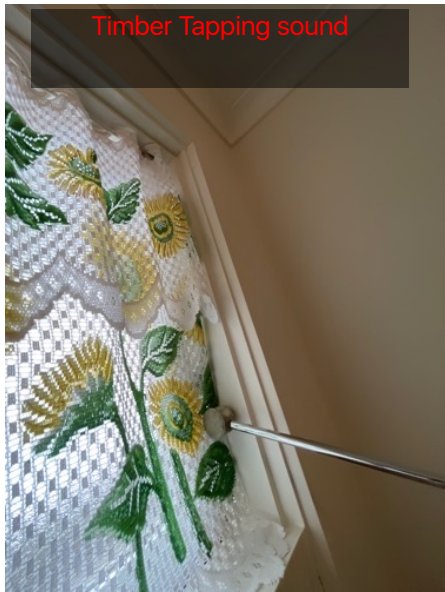
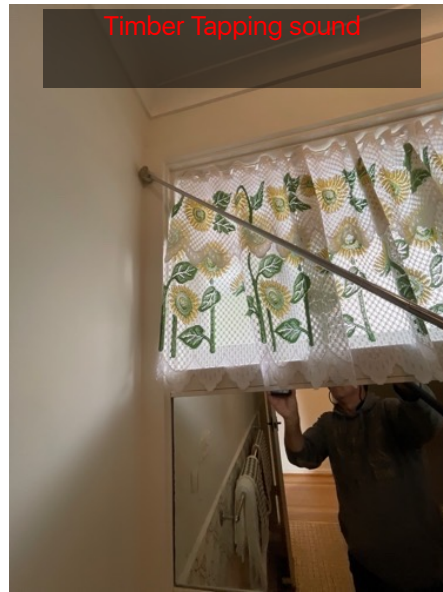
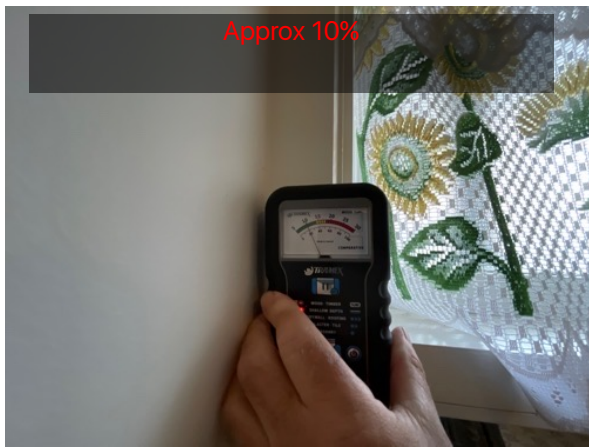
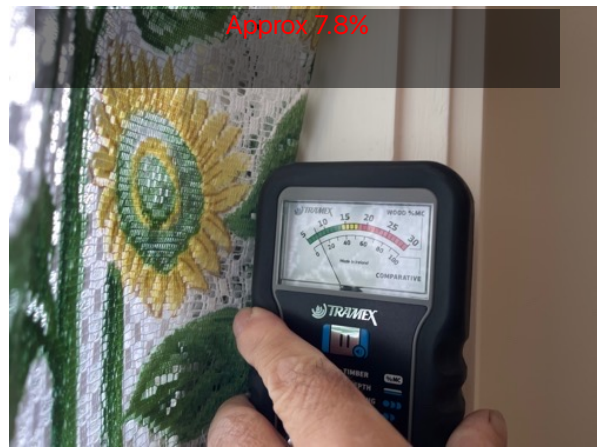
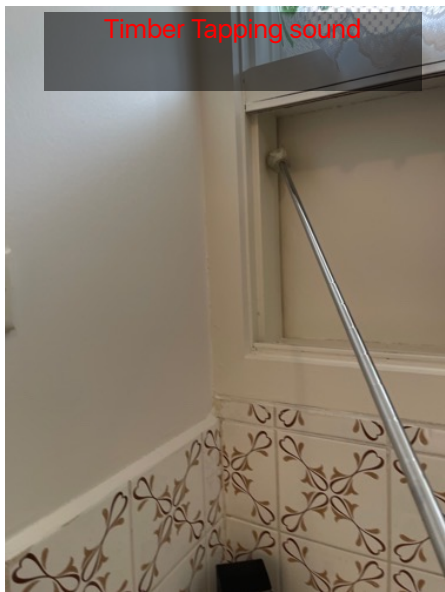
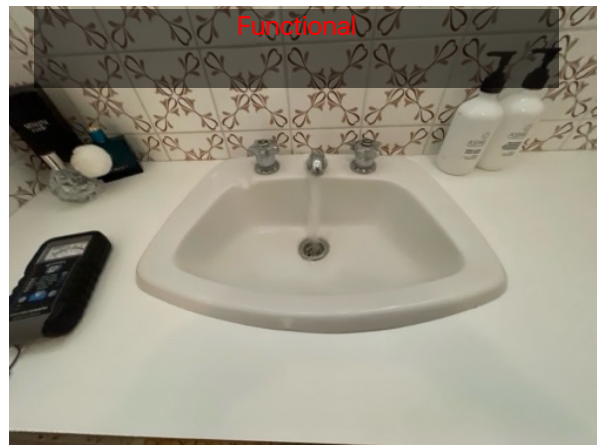
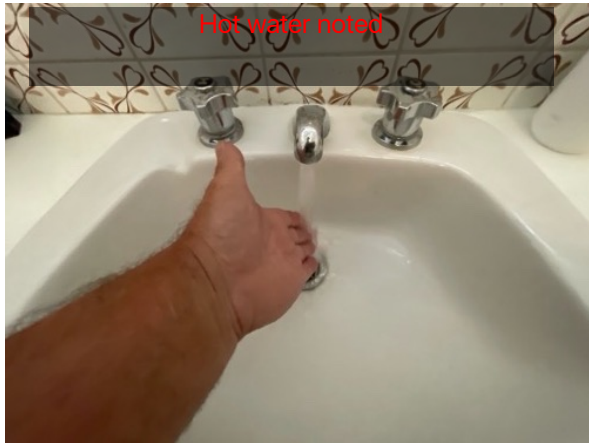
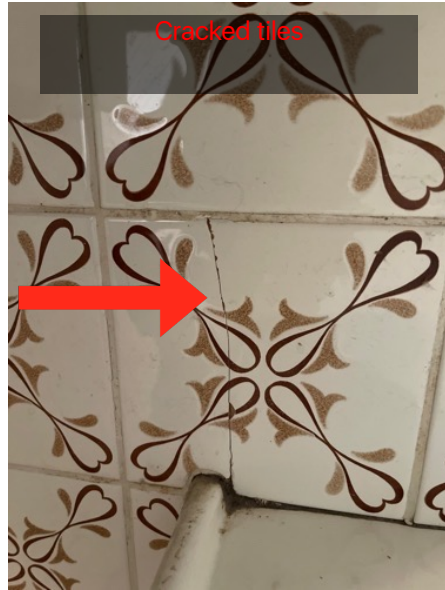
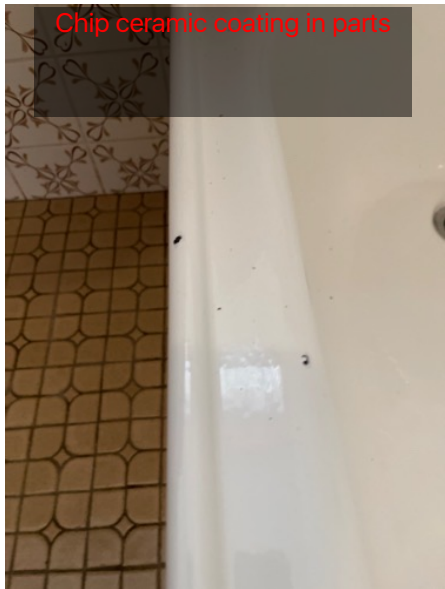
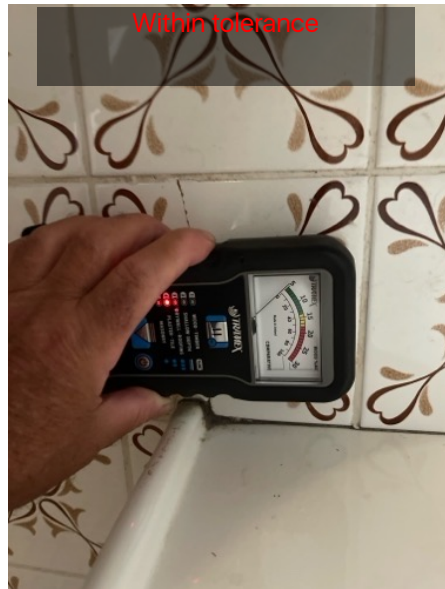
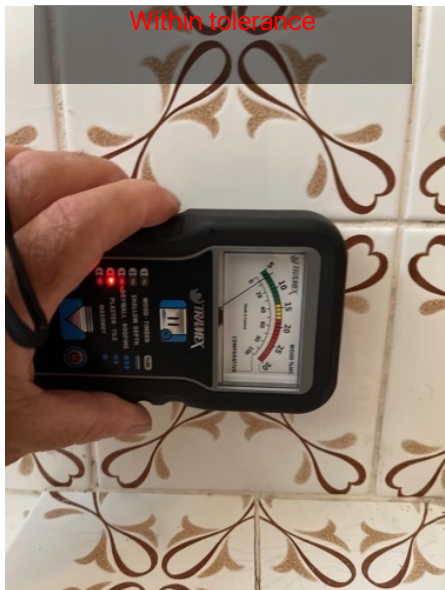
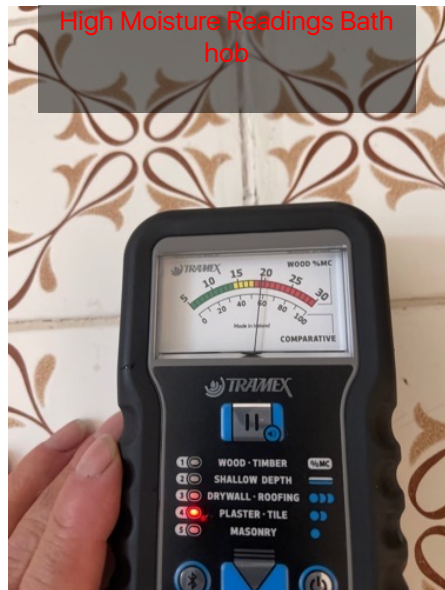
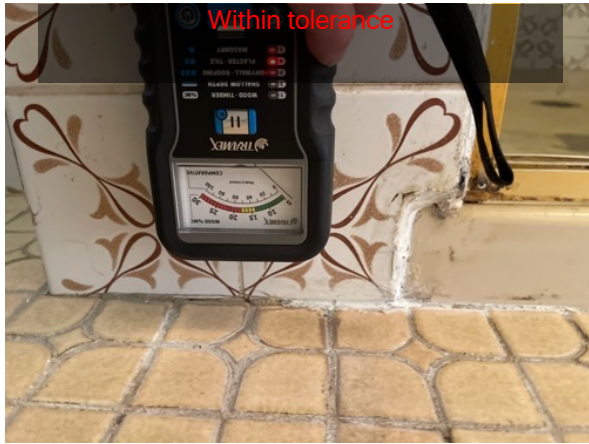
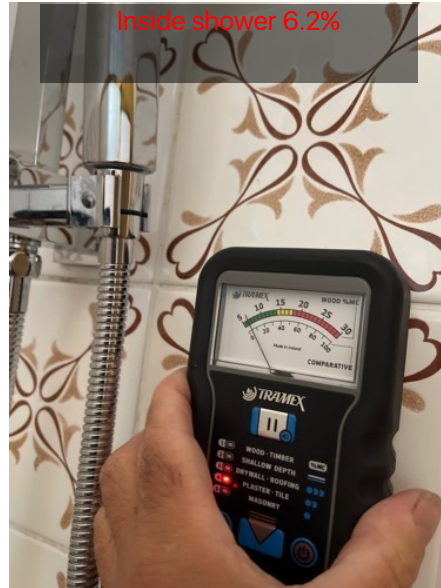
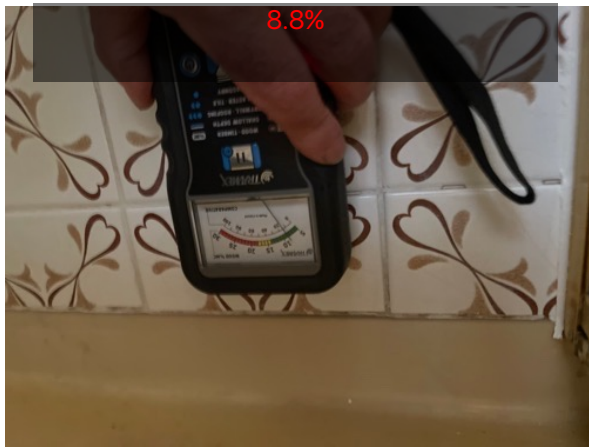
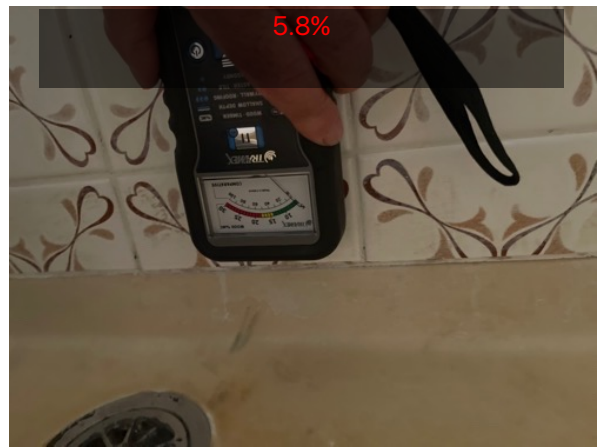
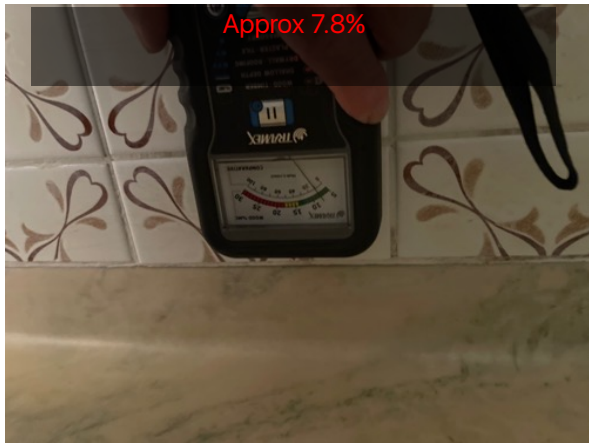
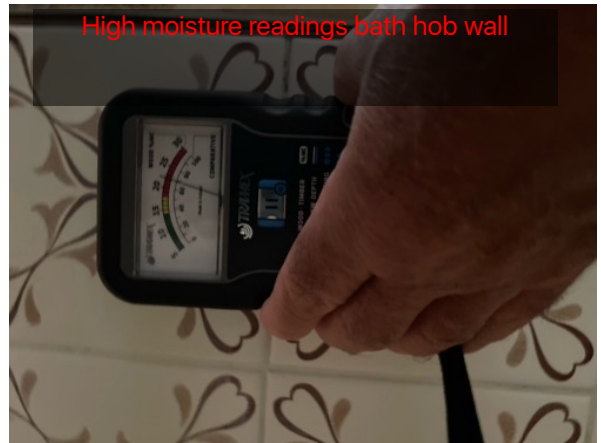
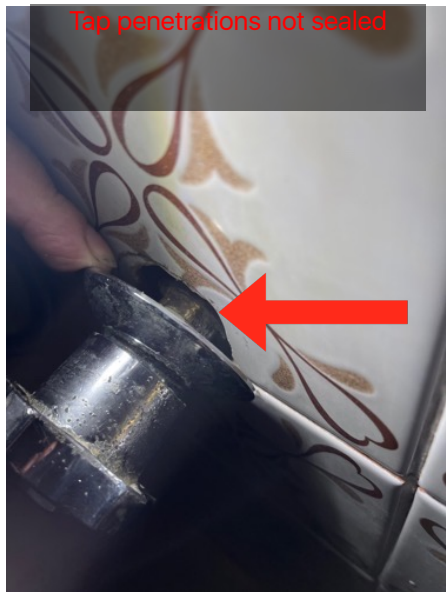
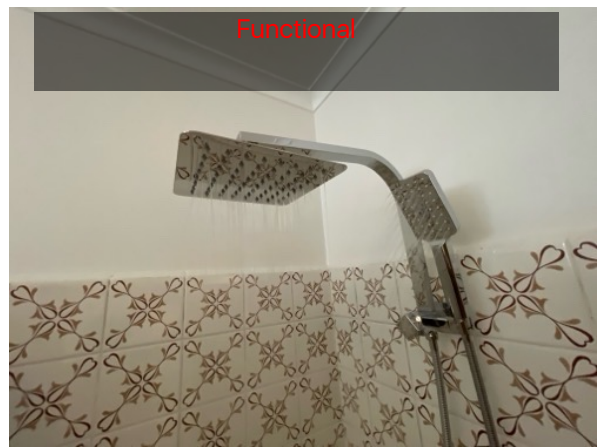
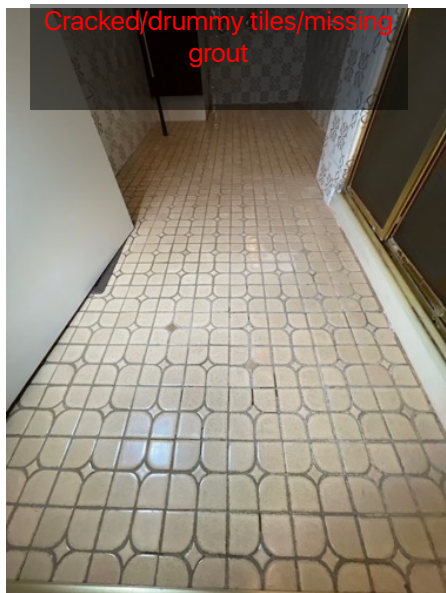
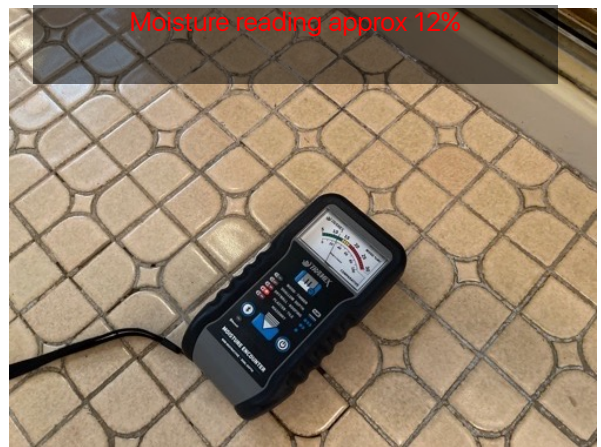
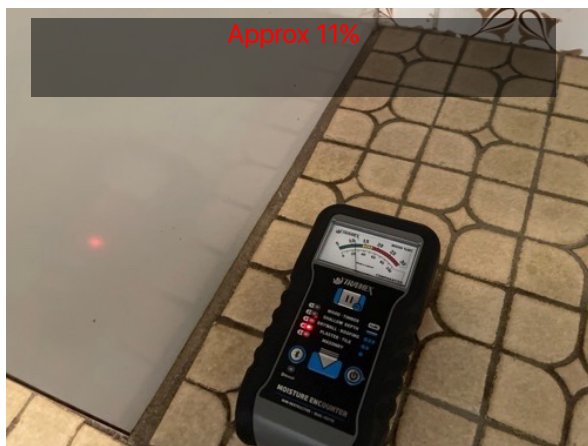
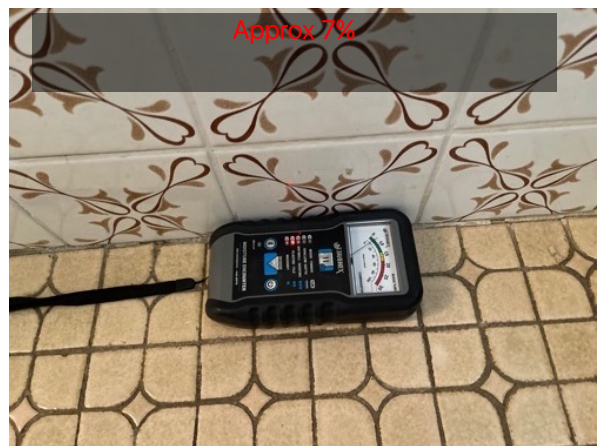
## Conditions conducive to timber pest attack 5.01

**Finding:** High Moisture Readings

General wear and tear noted throughout.

Cracked, drummy tiles and loose/missing grout noted to floor and wall tiles in parts throughout.

Variations to moisture readings noted to wall and floor tiles.

High moisture readings noted to bath hob outside shower and hob wall tiles inside shower.

Tap penetrations to shower recess not silicone sealed as required to prevent potential moisture ingress into structure and damage to surrounding building elements.

An invasive inspection may be required to determine cause of damage and high moisture readings and extent of damage and/or timber pest activities and infestations

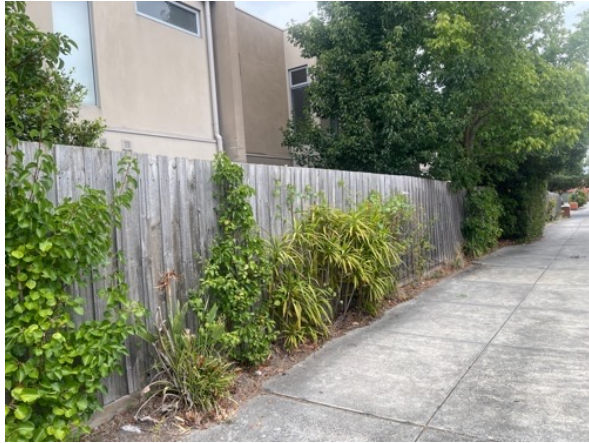
## Conditions conducive to timber pest attack 5.02

Fencing appears functional but weathered and leaning slightly in parts.  
Potential future body corporate costs to replace.

Replacement with a suitable durable material recommended

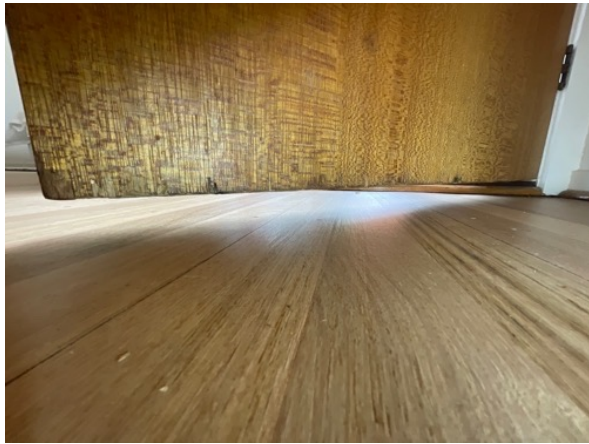
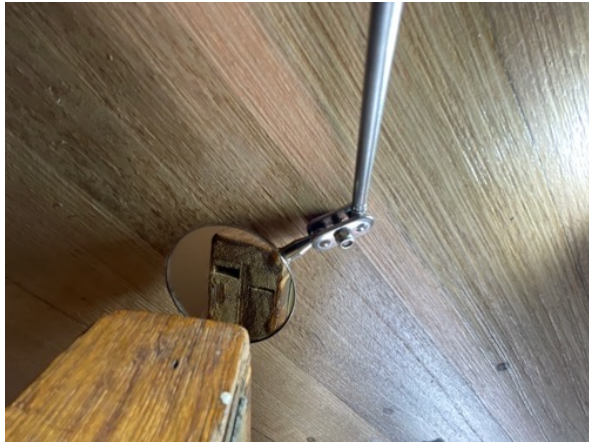
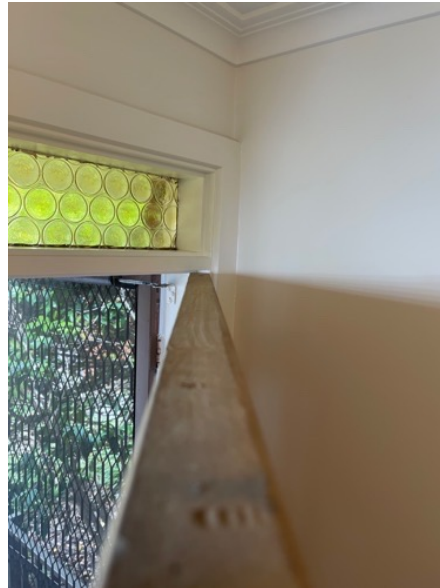
### Conditions conducive to timber pest attack 5.03

Front and outer face of entry door appears weathered in parts.  
Chipped ply noted to internal bottom edge.

Top and bottom edges of door not sealed to prevent potential moisture ingress damage

Door leaves are defective if they do not have all sides, top and bottom edges that are sealed to prevent moisture entering

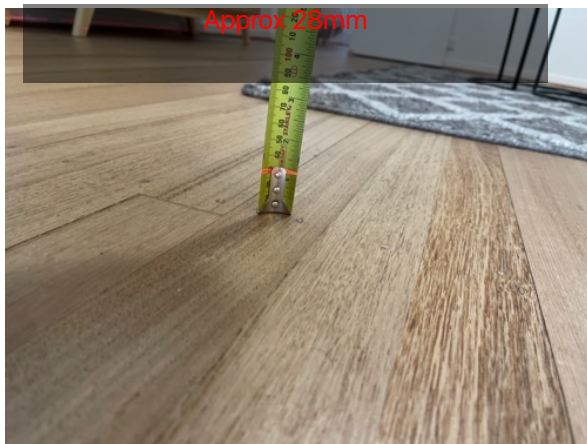
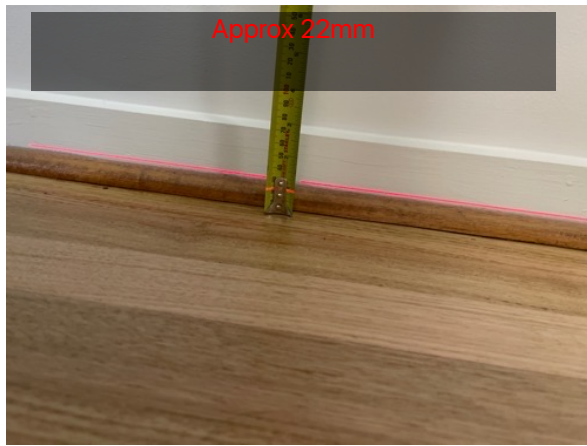
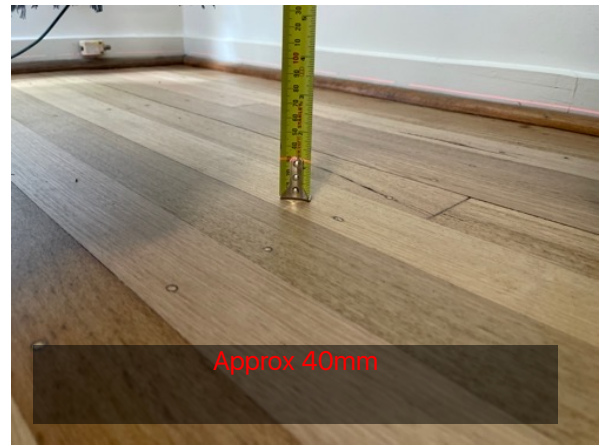
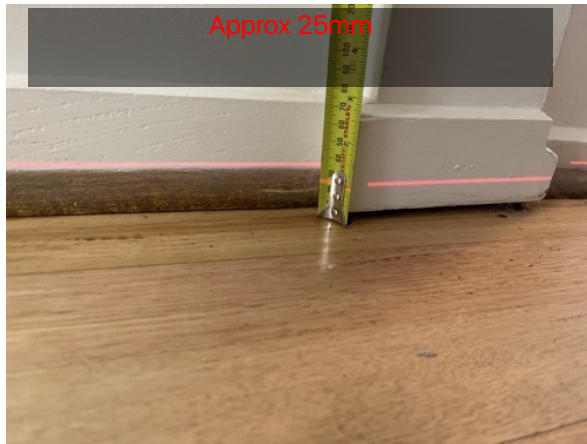
## Conditions conducive to timber pest attack 5.04

**Finding:** Flooring Level Defects

Variations of up to 18mm noted to flooring in parts throughout. (See pics below)  
Obstructed access inspection noted due to obstructed subfloor space access.

Floor levels within a room or area are defective if they differ by more than 10mm in any room or area, or more than 4mm in any 2m length. The overall deviation of floor level to entire building footprint shall not exceed 20mm

Patching noted to plaster wall and cornices to west side.

It may be probable to assume that property may require lift and packing at stumps if concrete stumps installed and in good condition.

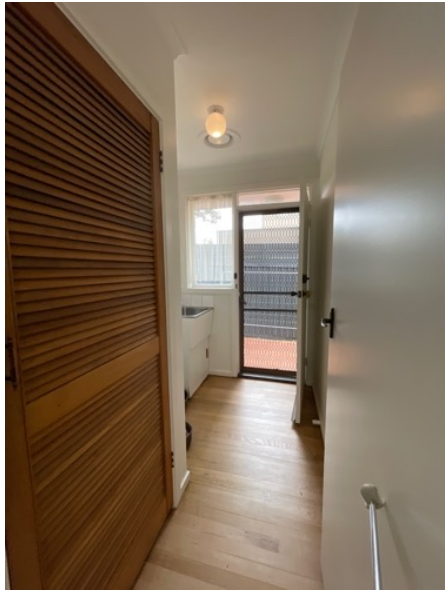
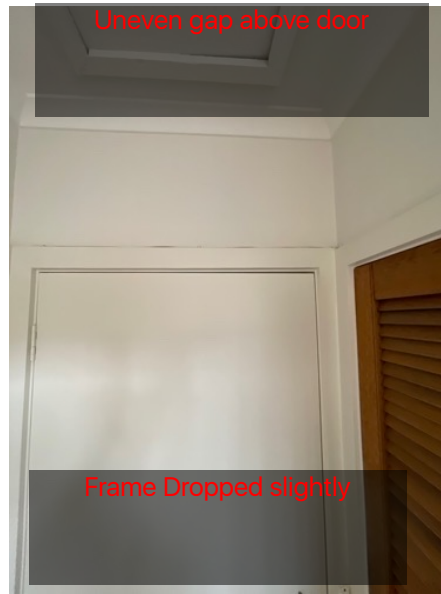
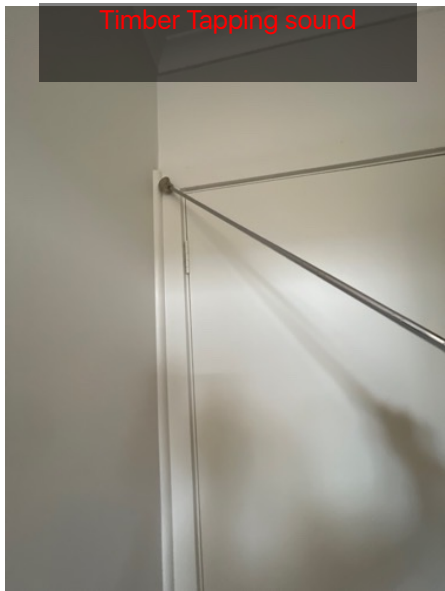
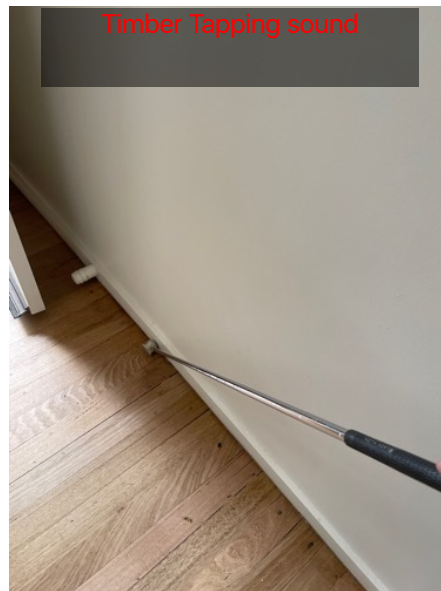
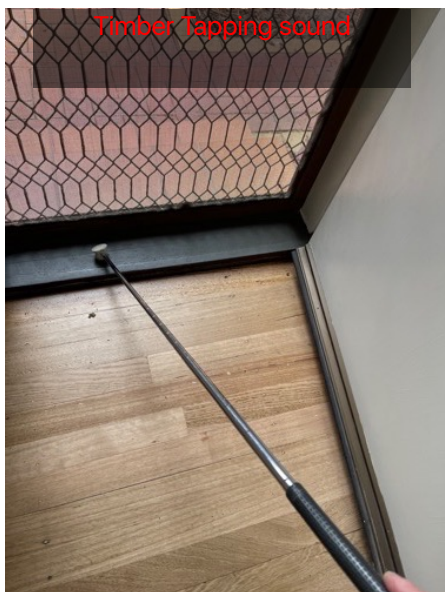
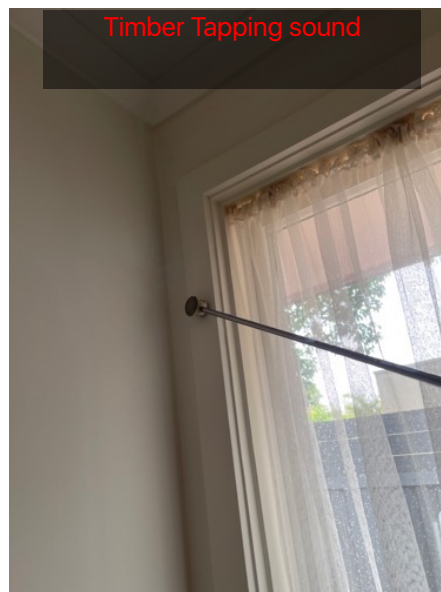
## Conditions conducive to timber pest attack 5.05

The laundry appeared functional and in relatively sound condition at the time of inspection. No notable structural damage noted.

Gaps noted to timber floor boards in parts, often associated with excessive moisture and common to laundry areas. Flooring appeared relatively sound.

All edges of doors not sealed to prevent potential moisture ingress damage.

Patching and mould stain noted to broom cupboard ceiling.

Old glue noted during roof space and exterior roof inspections suggested cupboard historically used for water heater/or heater storage.

Moisture Readings taken appeared within tolerances at the time of inspection

Removal of old glue and roof tile replacement recommended.

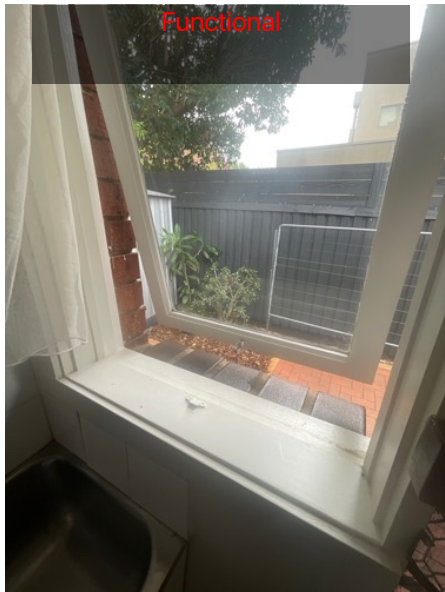
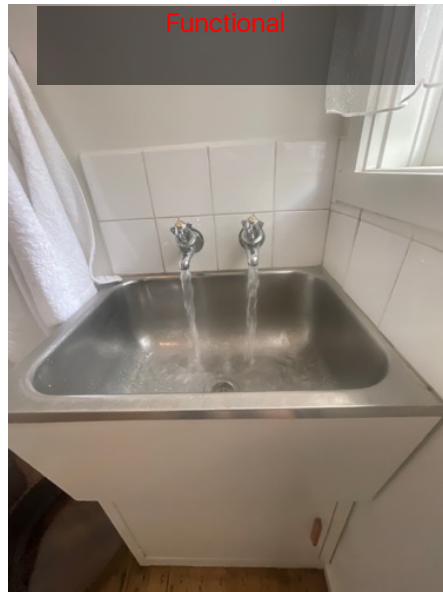
Functional

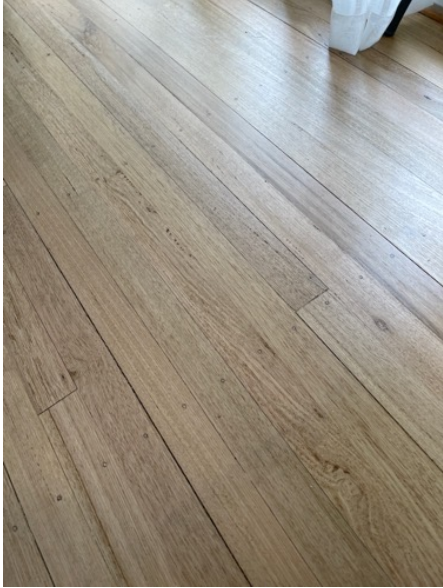
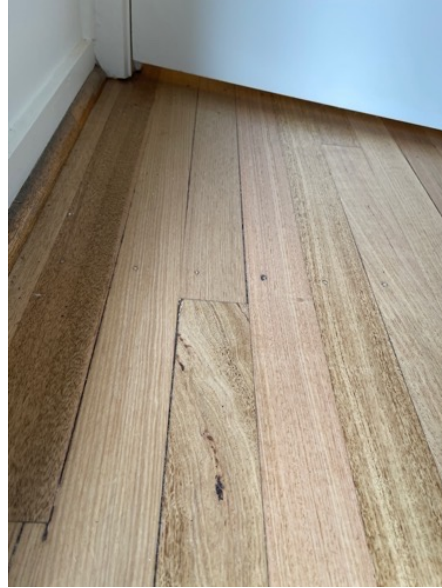
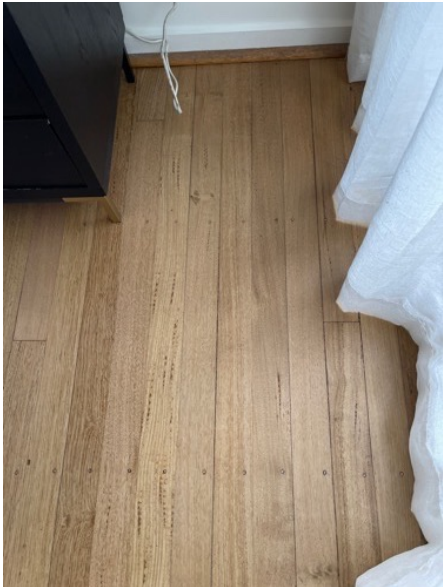
Done gapping noted to timber flooring in parts throughout property.  
Floor boards appear relatively sound.

Obstructed access noted to flooring in parts throughout property due to high volume of floor coverings and heavy furniture

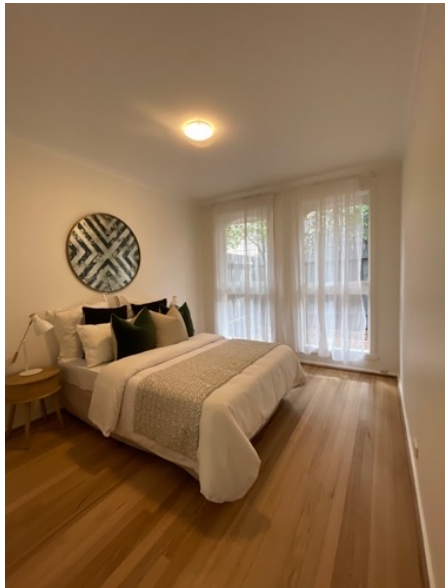
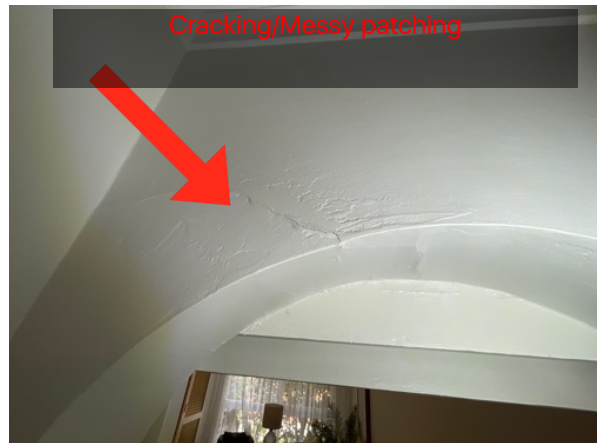
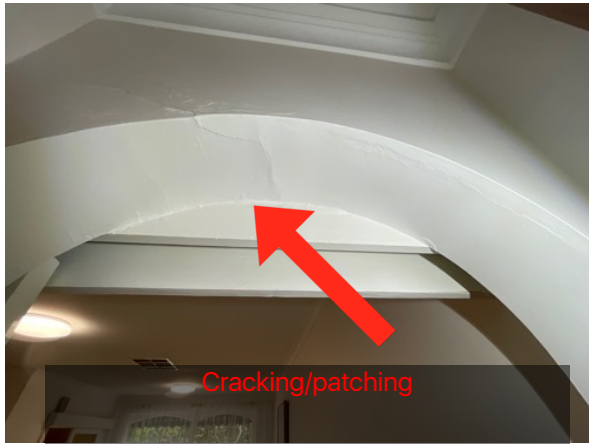
Cracking and patching noted to plaster archway and to ceiling above entry doorway.

No notable visible cause of cracking noted.

Qualified plasterer to repair and if cracks reoccur, an invasive inspection may be required to determine cause.

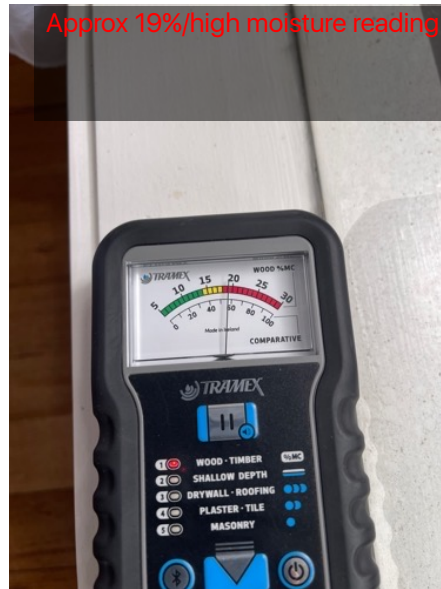
High moisture readings noted to window sill

Approx 19%/high moisture reading

An invasive inspection may be required to determine cause of patching damage and high moisture readings and extent of damage and/or timber pest activities and infestations.

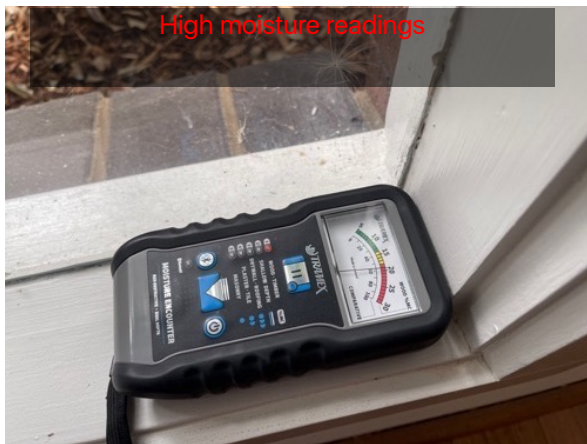
High moisture readings

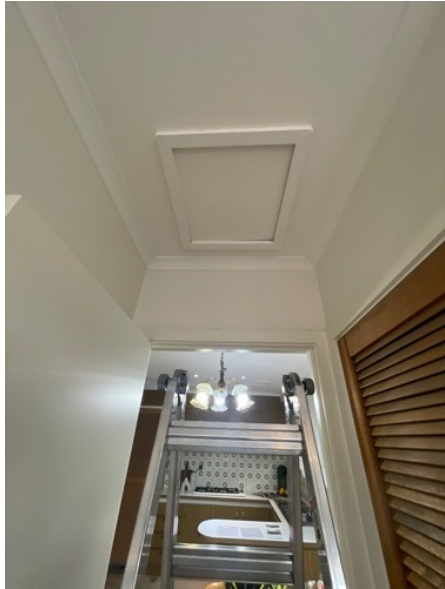
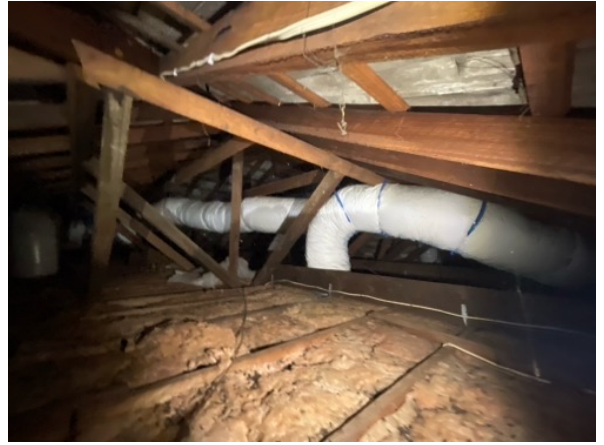
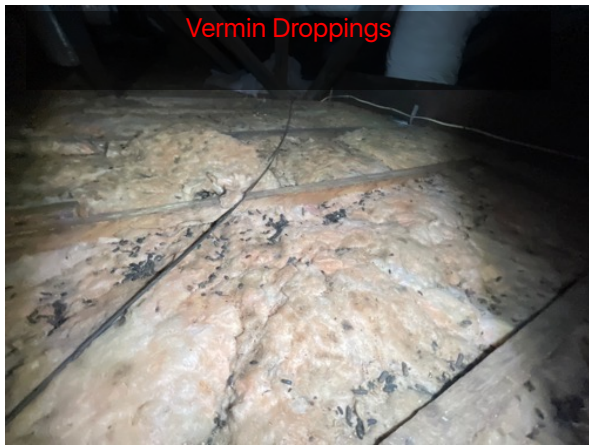
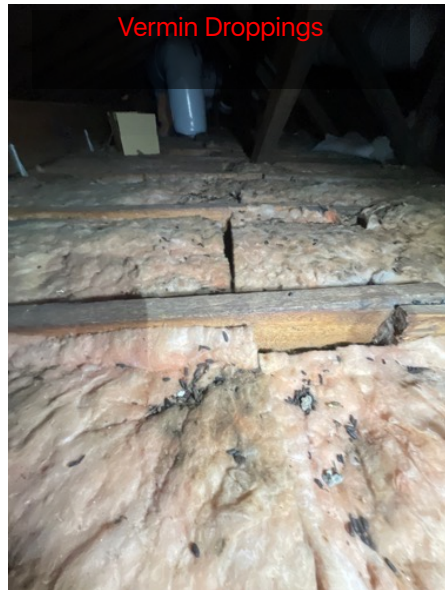
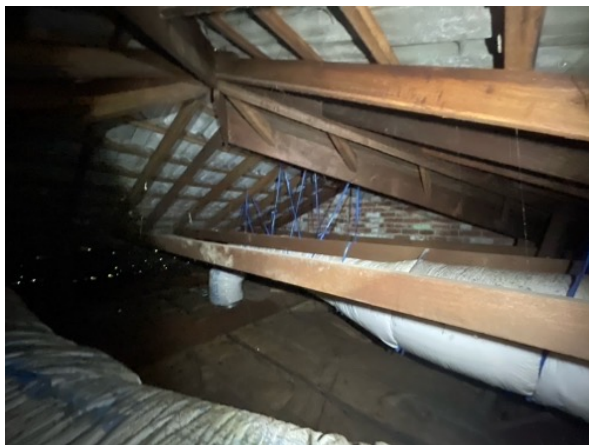
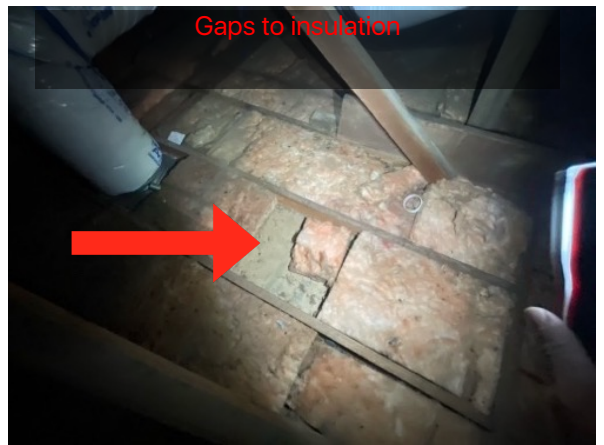
Where accessible and visual for inspection and tapping, timber framing members appeared functional and in relatively sound condition at the time of inspection. Obstructed access inspection noted due to high volume of stored goods including but not limited to: insulation, electrical and ductwork components and low framing members restricting crawl space. It is essential that full access be gained to all areas for the purpose of a building and timber pest inspection as they may be concealing timber pest activities and infestations and damage to surrounding building elements

Some gaps noted to insulation in parts, reinstate to improve energy efficiency.

Engage a qualified insulation specialist to inspect and advise

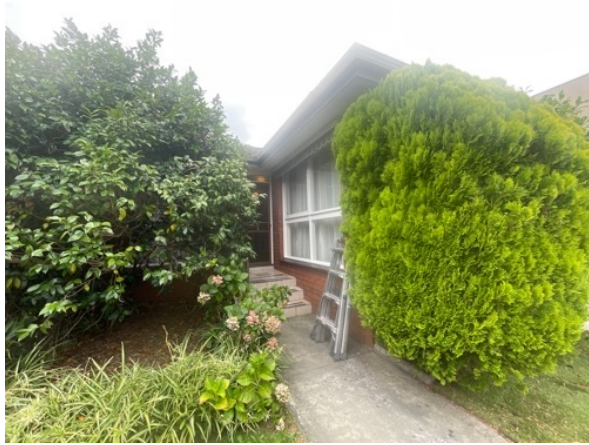
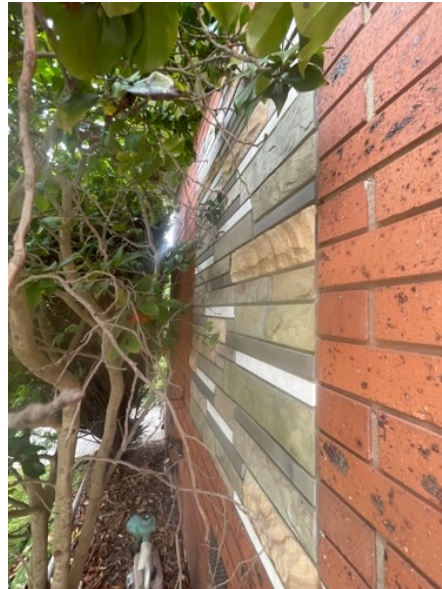
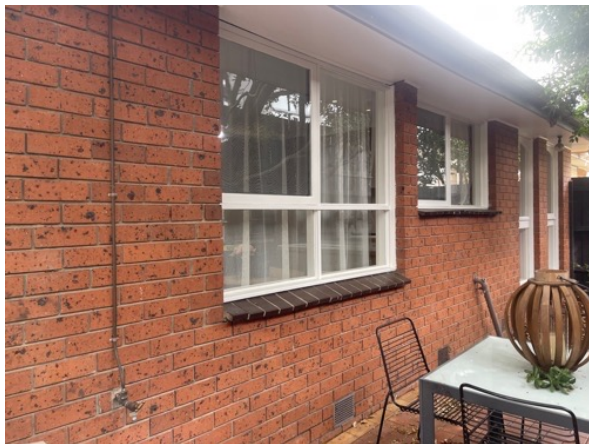
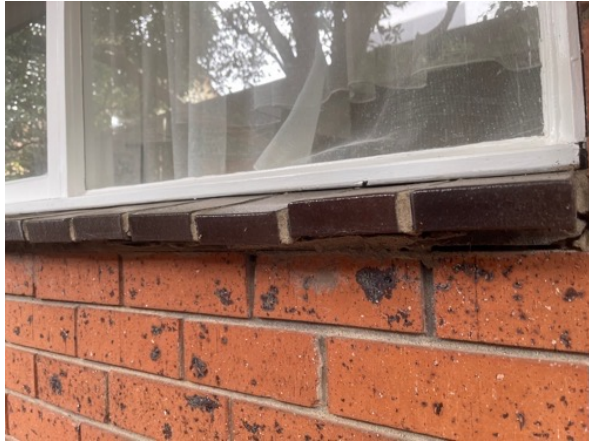
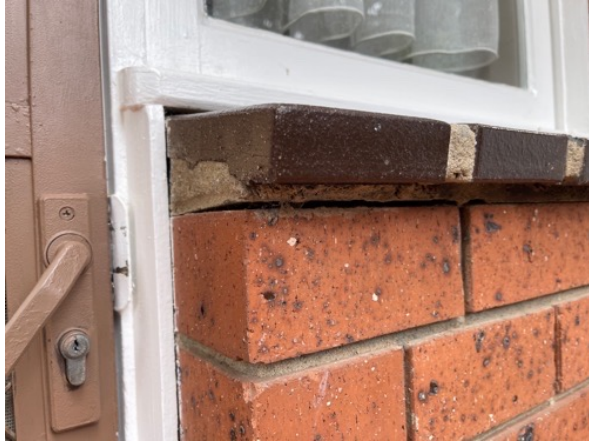
**Finding:** Brickwork/Loose Sill Tiles

Loose sill tiles and cracking to tile mortar noted in parts throughout.  
Not uncommon for this type of construction.

Loose sill bricks potential areas of moisture ingress into structure and damage to surrounding building elements and conditions conducive for timber pest activities and infestations.

Engage a qualified bricklayer to inspect and advise on refitting costs.

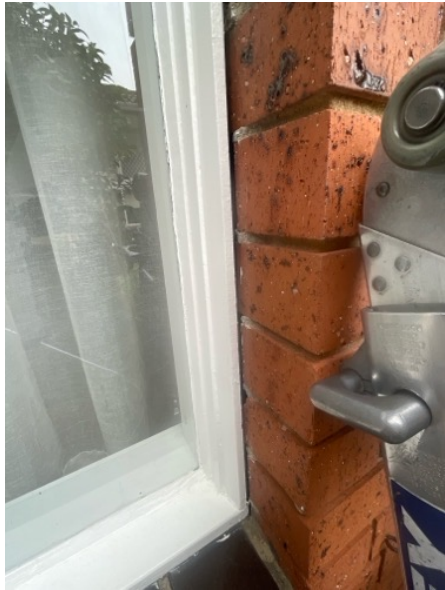
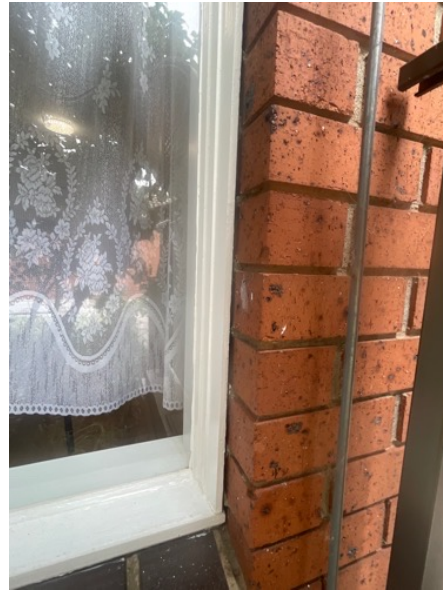
Some gaps noted at window and/or door openings in parts throughout.

Installation of a suitable flexible sealant recommended to prevent moisture ingress into structure and damage to surrounding building elements

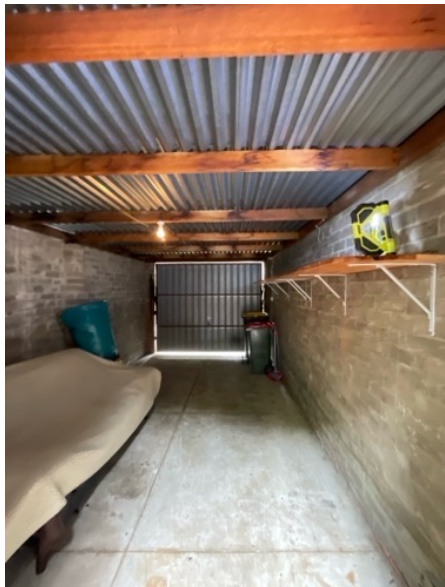
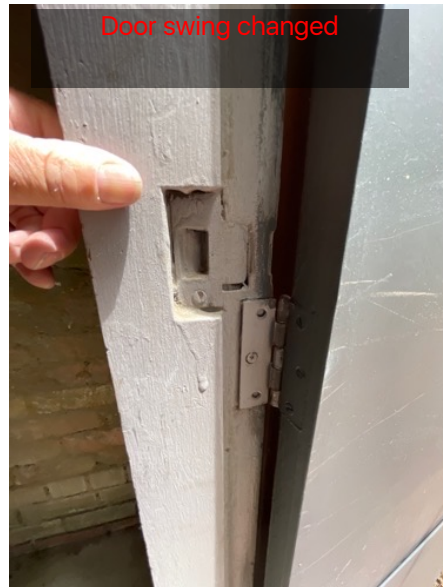
**Finding:** Garage/Moisture Damage

Moisture Ingress damage noted to roof timber framing in parts to garage perimeter. Timber appears soft to tap to southeast corner.

Timber garage exit door damaged in parts. Repairs, replacement recommended. No working door lock noted.

An invasive inspection required to determine extent of damage and/or timber pest activities and infestations.

Licensed roof plumber to inspect roofing for water tightness and repair as required.

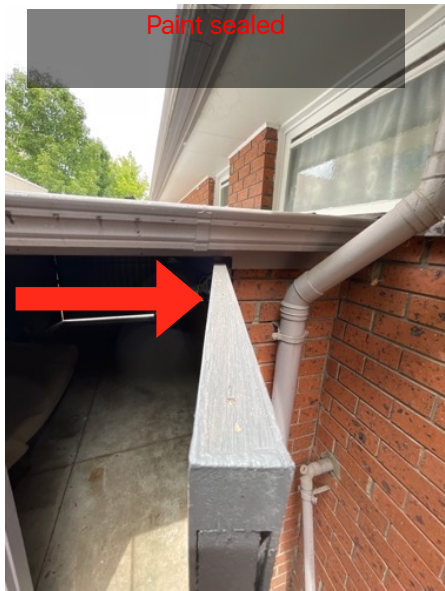
Paint sealed

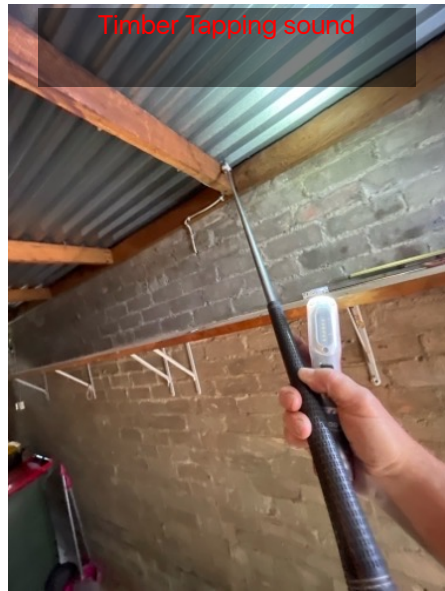
Timber Tapping sound

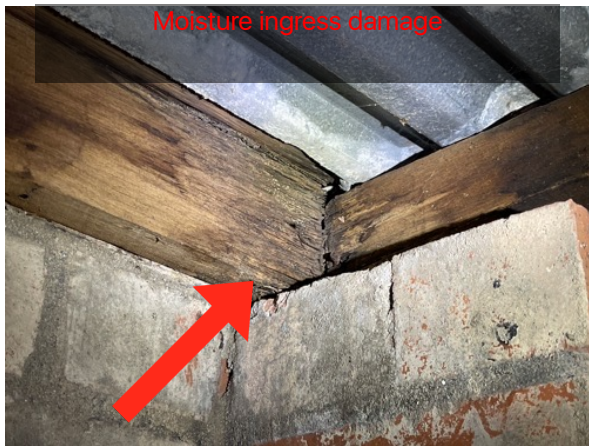
Moisture ingress damage

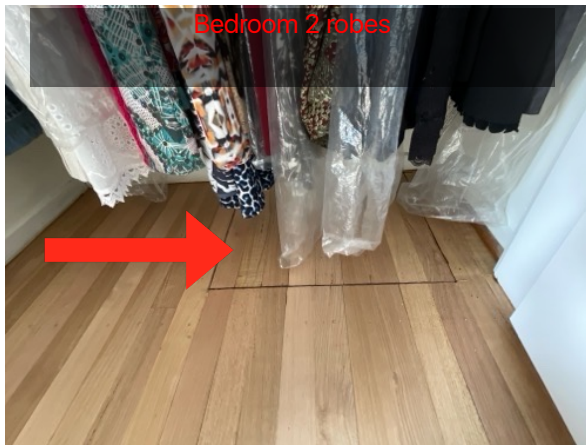
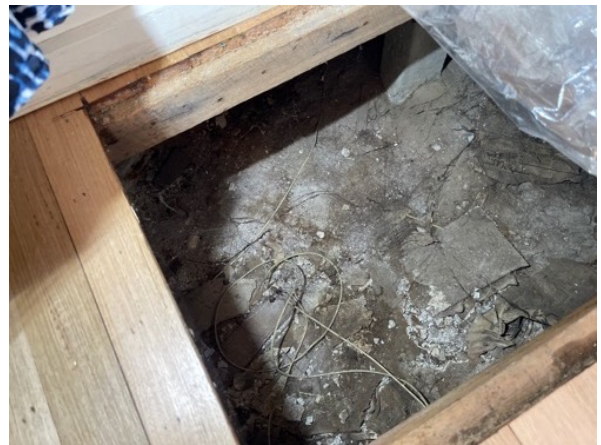
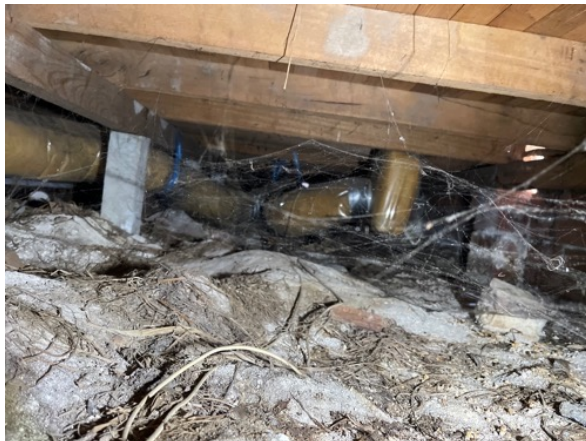
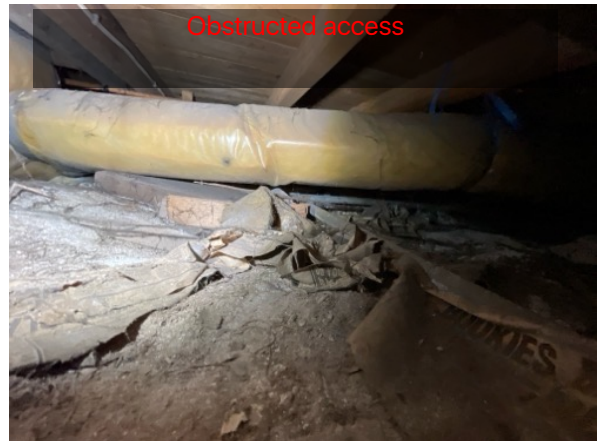
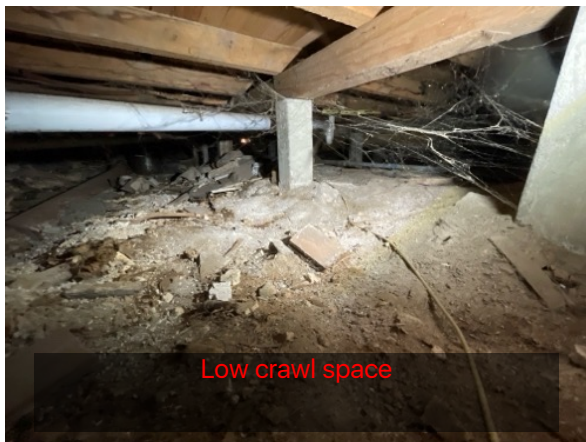
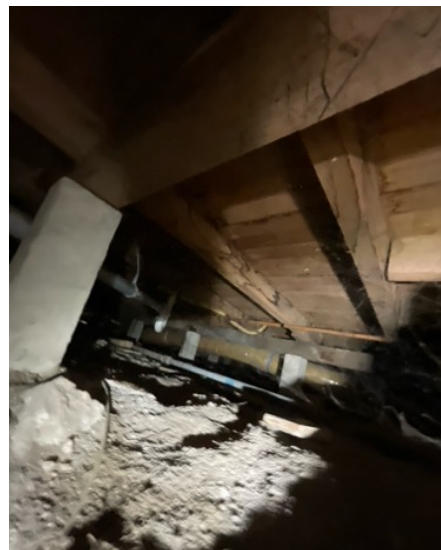
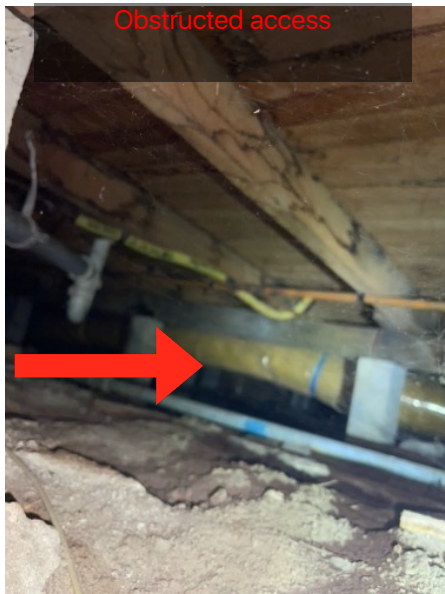
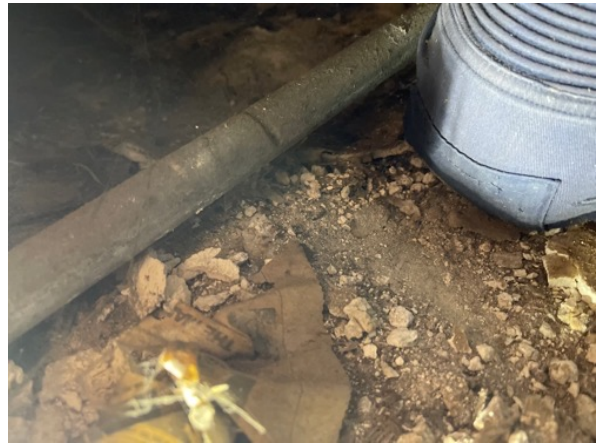
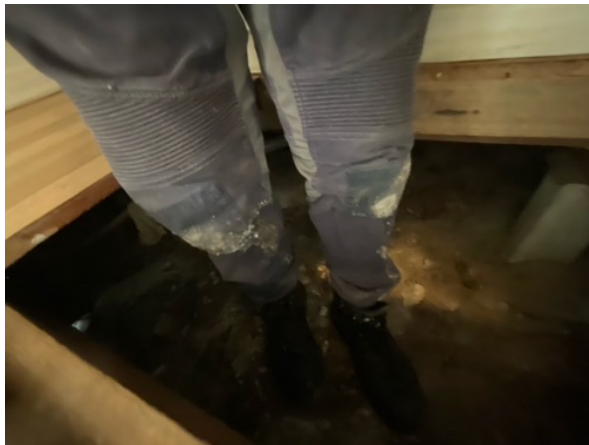
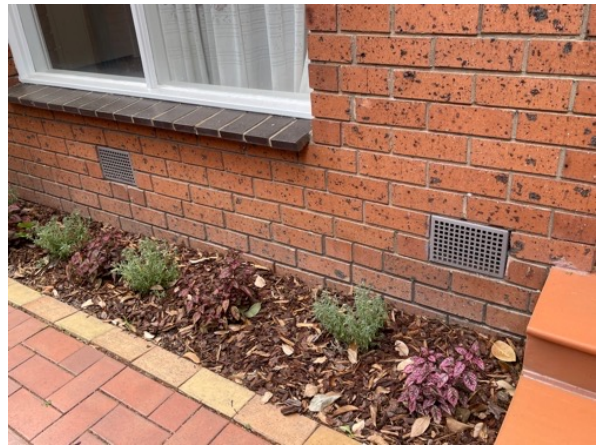
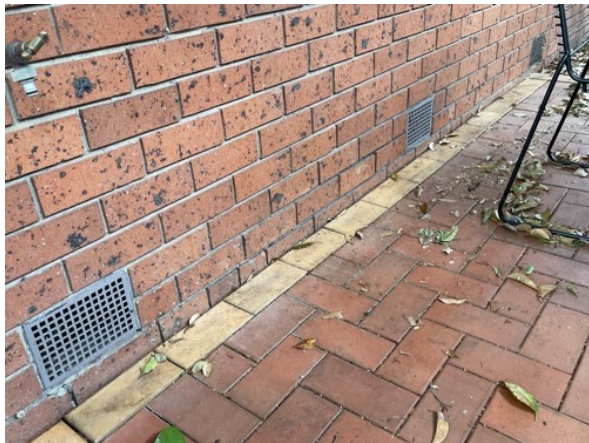
Obstructed access inspection noted to subfloor due to location of access point, uneven ground, building rubble and debris, low hanging plumbing components and low proximity of structure to finished ground level obstructing reasonable safe access.

It is essential that full access inspection be gained to all areas for the purpose of a building and timber pest inspection as they may be concealing timber pest activities and infestations and damage to surrounding building elements

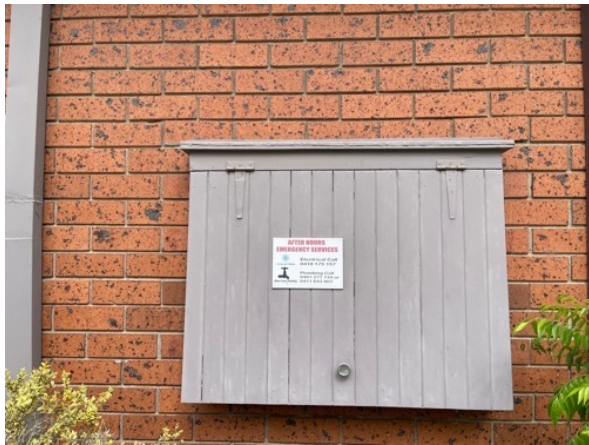
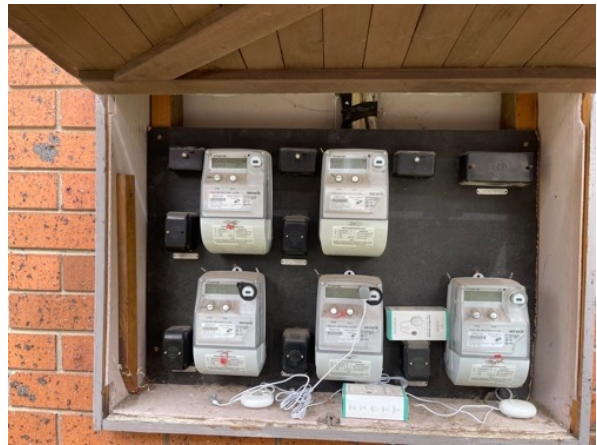
No termite treatment management plan durable notice noted to meter box/property at the time of inspection.

It may be probable to assume that inspected property may not be protected from termite activities and infestations.

A termite treatment management plan is always recommended to prevent possible future and/or concealed present termite activities and infestations
