**IDBPI**  
**INSPECT DETECT BUILDING &  
PROPERTY INSPECTIONS**

Inspection Date: 23 Jan 2025

Property Address: Carnegie

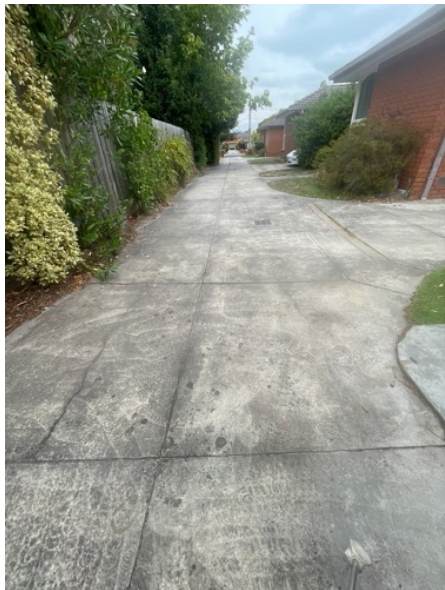
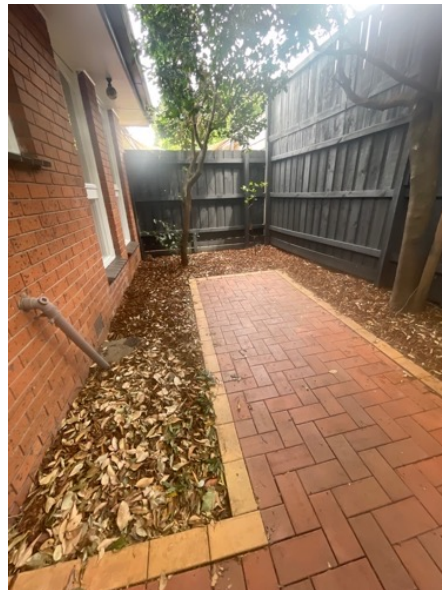
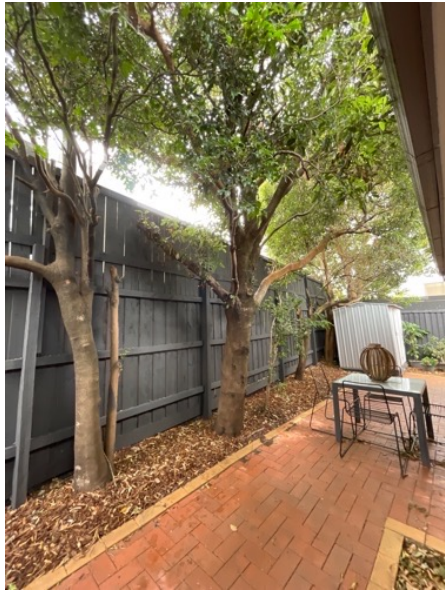
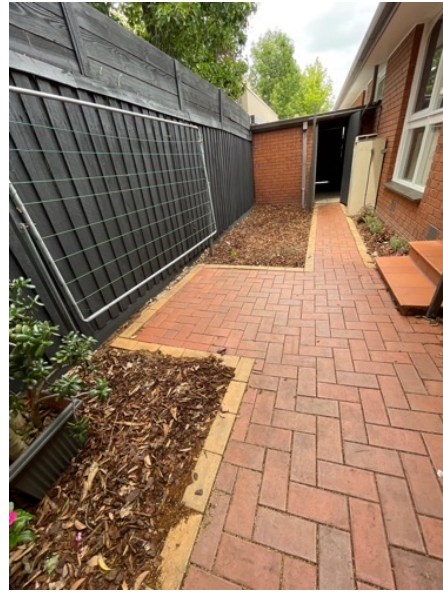
**Finding:** Concrete Cracking/Conductive Conditions

Cracking noted to concrete pavement in parts.

Timber garden mulch areas and large trees noted against and/or around structure deemed highly conducive for timber pest activities and infestations.

Cracking to concrete at times unavoidable and should always be documented and monitored for movement over a period of time and if increases noted, engage a structural engineer to inspect and advise.

A drainage inspection of older properties recommended.

A termite treatment management plan strongly recommended to inspected property to protect property from possible future and/or concealed timber pest activities and infestations

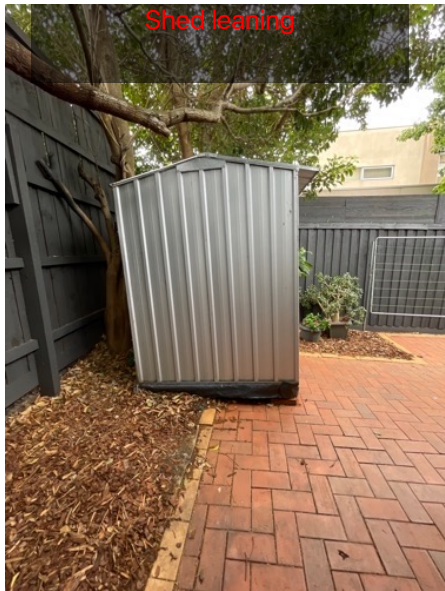
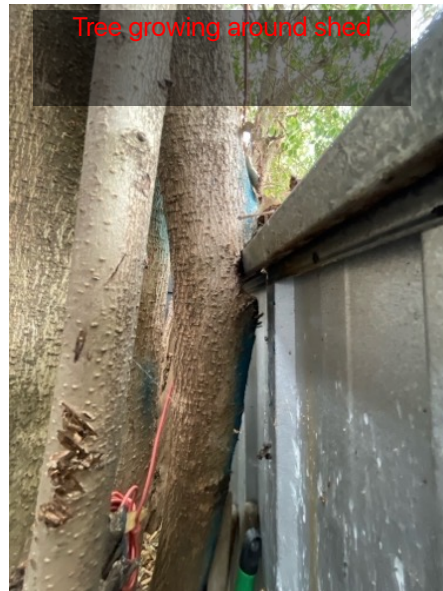
**Finding:** Shed Obstructed Access

The shed poorly installed and leaning against trees. Trees growing over shed. Shed was locked at time of inspection obstructing full access inspection.
